**WEST VIRGINIA DEPARTMENT OF ENVIRONMENTAL PROTECTION  
WV OIL AND GAS CONSTRUCTION STORMWATER PERMIT**

<b>FACILITY NAME:</b>	Atlantic Coast Pipeline			<b>REG. #</b>	<b>EXPIRE DATE:</b>
<b>PERMITTEE</b>	DOMINION ENERGY TRANSMISSION, INC.			WVR310820	12/31/2018
<b>ADDRESS/PHONE:</b>	Attn: LESLIE HARTZ, VICE PRES 707 E. MAIN ST. RICHMOND, VA 23219 8047714468				
<b>LOCATION:</b>	CR 22 / Buckhannon River			<b>Entry Date/Time:</b>	6/28/2018 @ 10:00
<b>COUNTY:</b>	Upshur			<b>Exit Date/Time:</b>	6/28/2018 @ 17:35
<b>Site Representative /Phone</b>	Derek Loftis / (931)644-7377			<b>PHOTOS</b> <input checked="" type="checkbox"/>	
<b>CO-PERMITTEE:</b>				<b>ADDRESS:</b>	
<b>SITE OPERATOR:</b>	Michels Pipeline Construction			<b>ADDRESS:</b>	817 Main St., Brownsville WI 53006
<b>PERMITTED ACREAGE</b>	2497	<b>WEATHER:</b>	Sunny	<b>LAST INSPECTION:</b>	5/24/2018
<b>RECEIVING STREAM(S)</b>	Buckhannon River/ Trubie Run/ Grassy Run/ Gravel Run/ Laurel Run				<b>NOV: W18-49-074-TJC</b>
<b>Regular Mail</b> <input type="checkbox"/> <b>Certified Mail</b> <input checked="" type="checkbox"/>		<b>Tracking # 70180040000047936016</b>

<b>OVERALL FACILITY RATING:</b>		Unsatisfactory		<b>COMPLIANCE OUTCOME

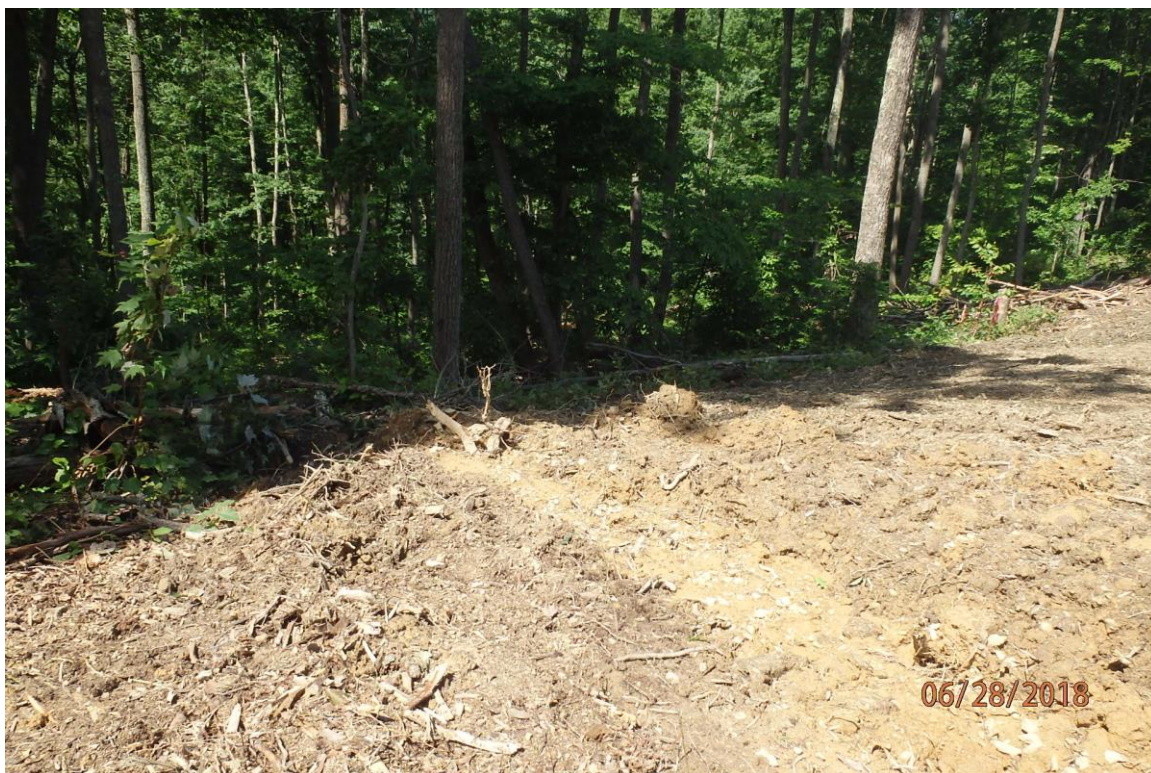
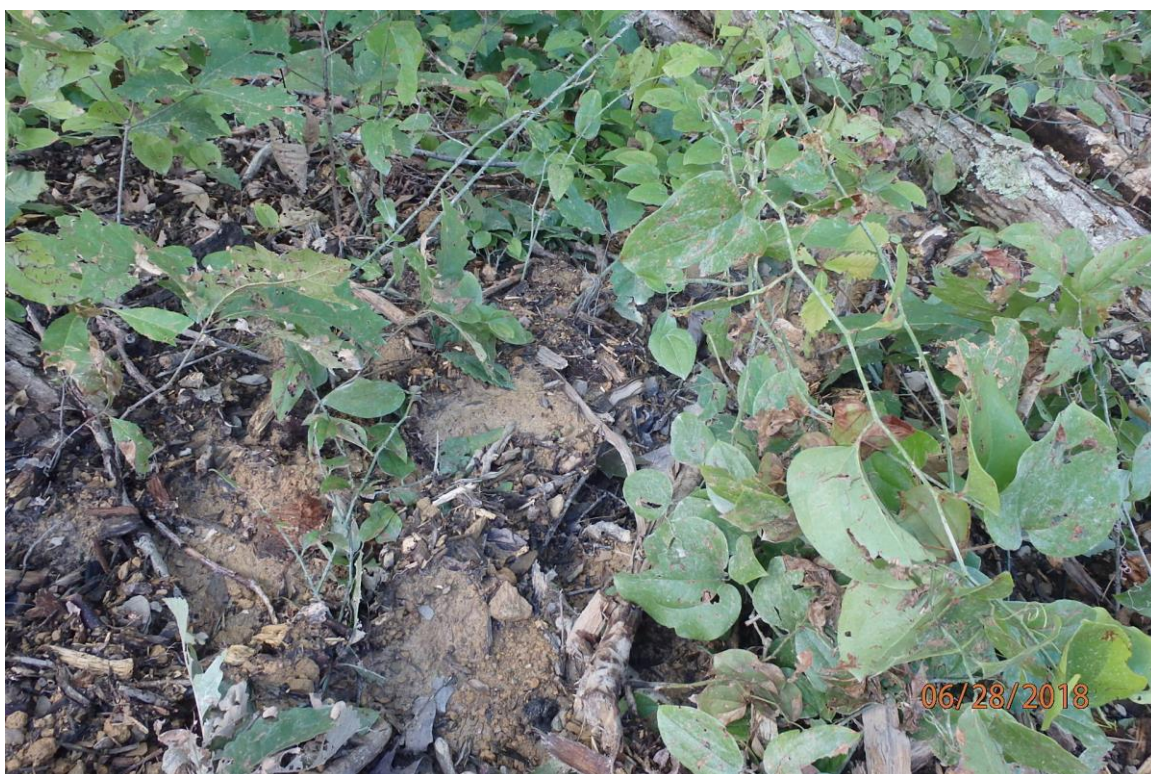
- 1). (1, 13, 15, 19 & 21) (Marginal) The project area from the Laurel Run crossing to 1904+00 was disturbed to mineral soil by mechanical clearing and lacked treatment at the terminus of water bars as indicated on the SWPPP. Perimeter silt fence (BSRF) was indicated in the SWPPP for upland areas of this section and it was not in place as described in the plan. As a result, small amounts of offsite sediment deposits were noted.

Temporary slope breaker that lacks treatment at the outlet adjacent to 1912+18 and the associated offsite sediment deposits. Marginal deficiencies in site evaluation item numbers 1, 13, 15, 19 & 21 pictured.

**WARNINGS: Immediately take all measures necessary to comply with all terms and conditions of the WV/NPDES general permit. Section B: Install all BMPs that are indicated in the SWPPP in all disturbed areas of the project. Section G.4.c: Modify the approved SWPPP and install additional controls at the ephemeral stream crossing adjacent to 1878+00. Section G.4.e.2.: Install all BMPs as designed.**

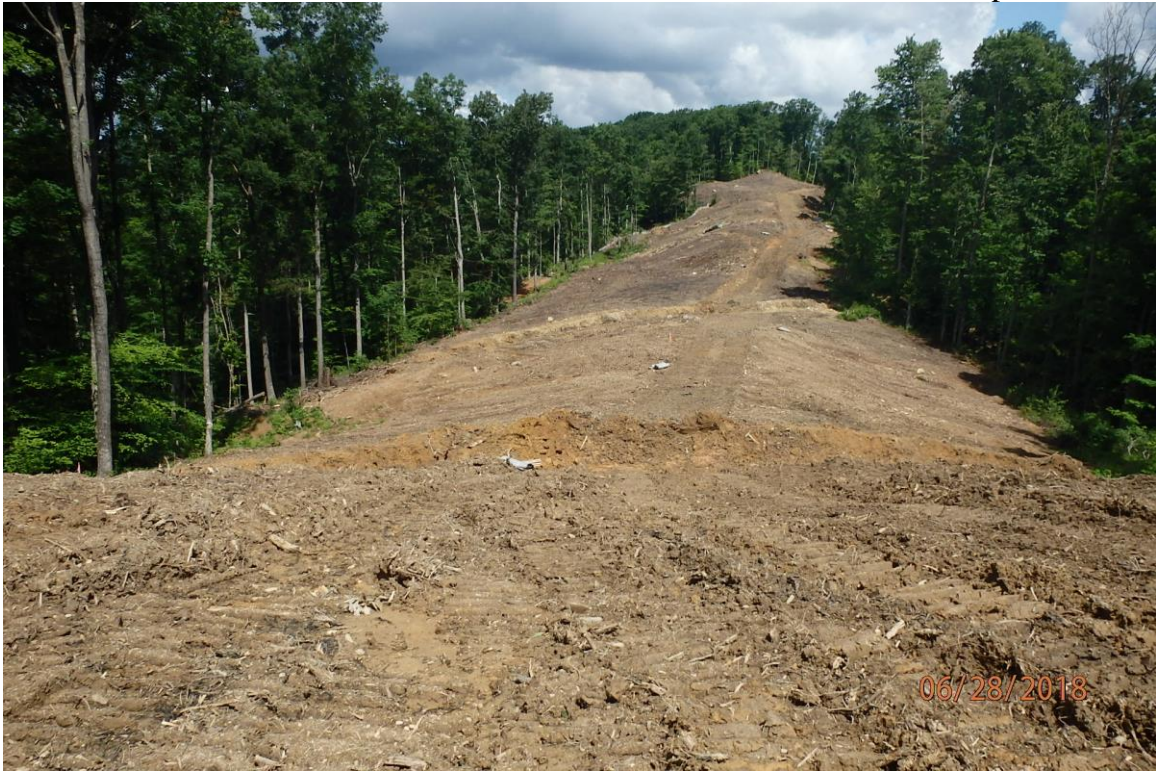
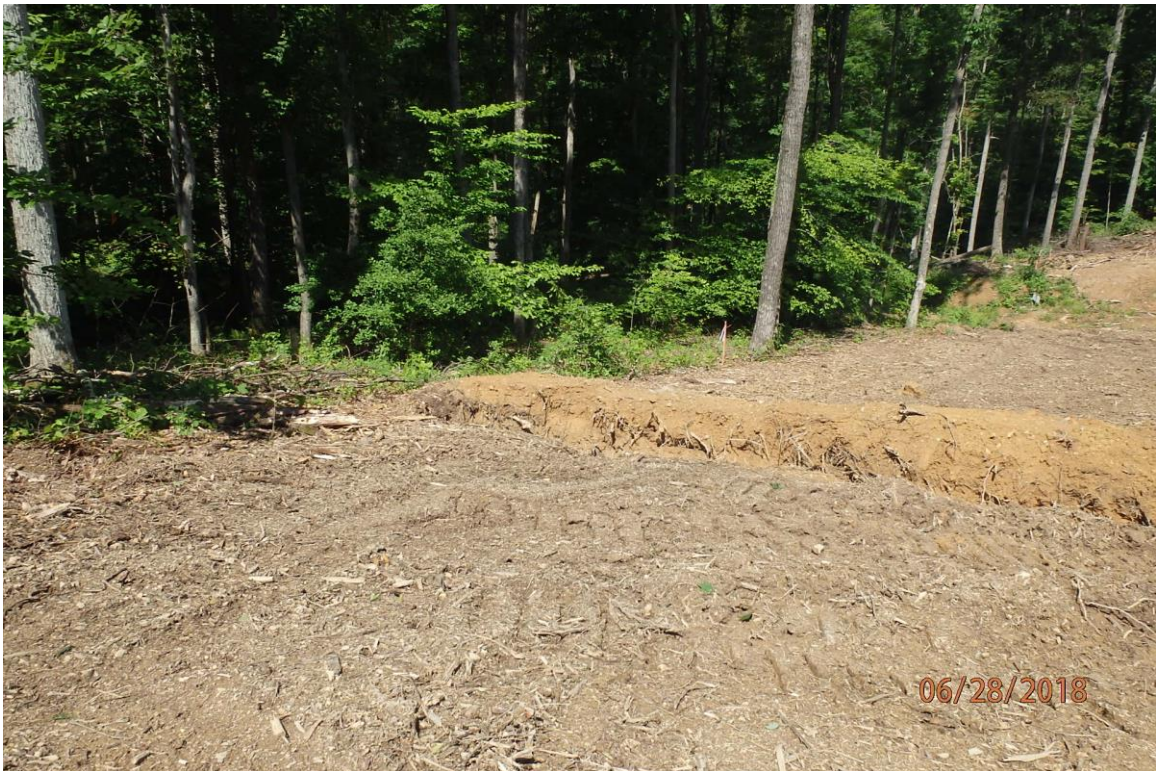
Project area at 1906+00 showing disturbed soil and a lack of treatment at the terminus of the temporary slope breakers and a lack of perimeter silt fence (BSRF) as indicated in the approved SWPPP. Marginal deficiencies in site evaluation item numbers 1, 13, 15, 19 & 21 pictured.

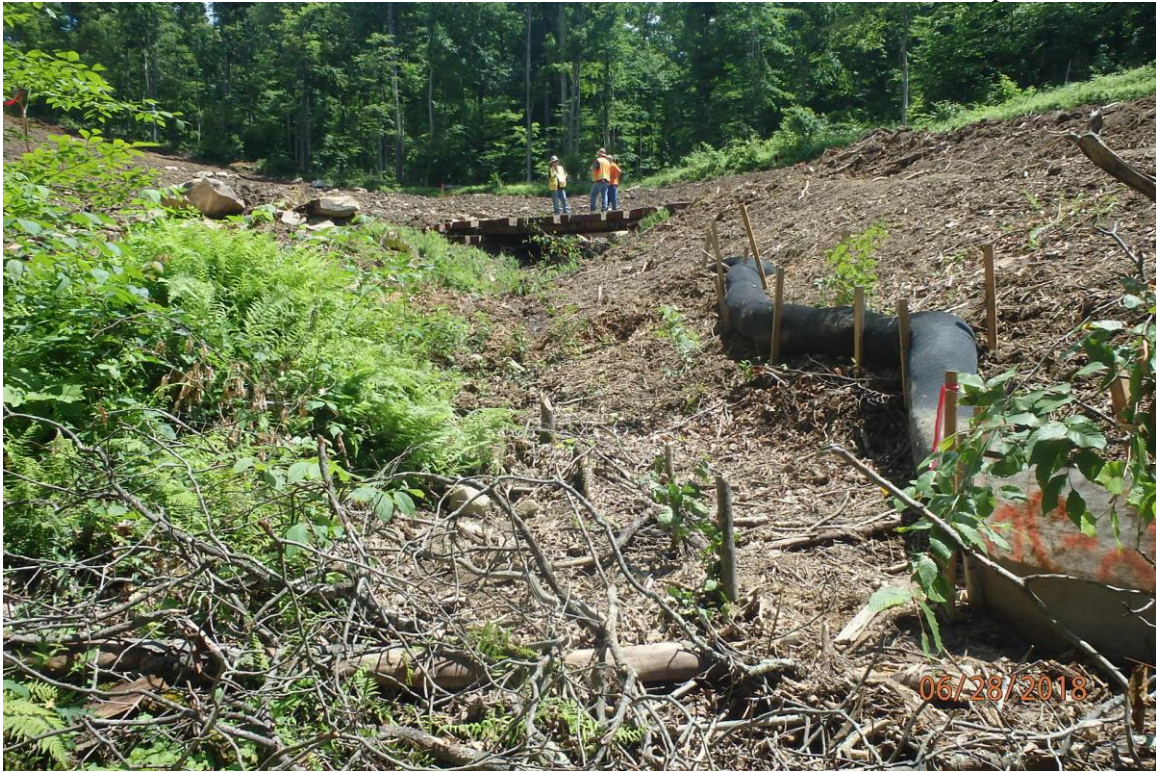
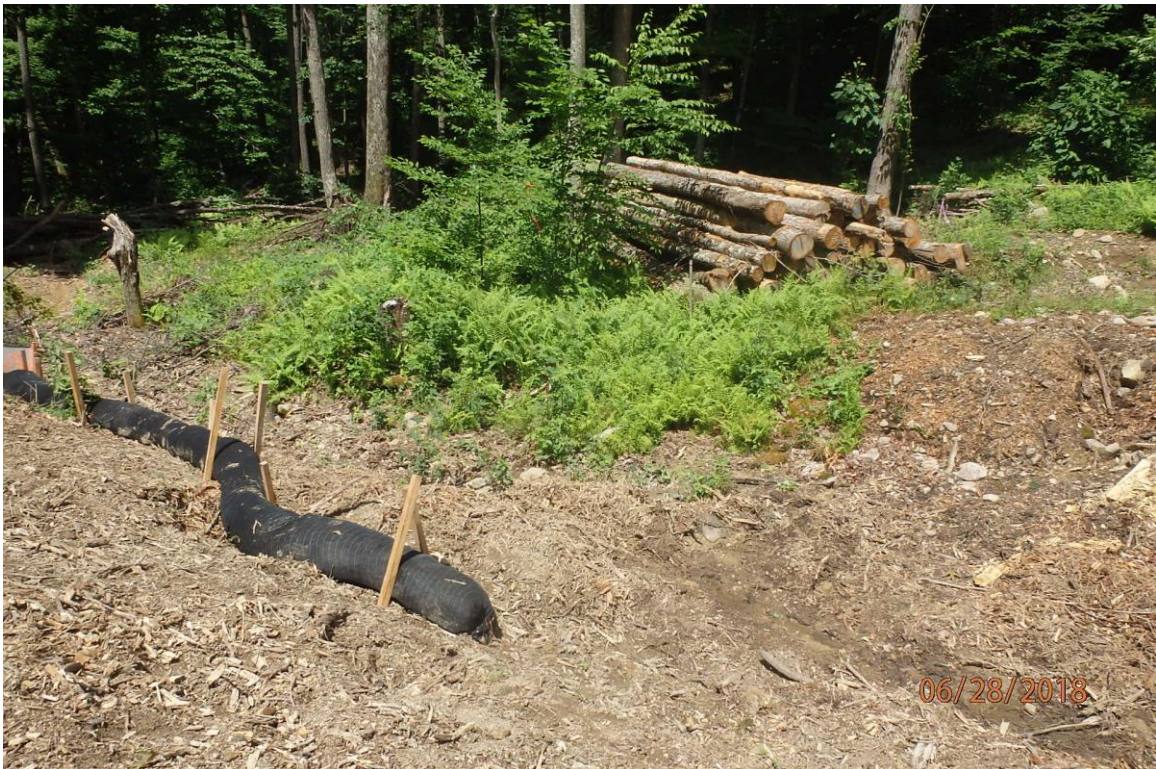
- 2). (1, 13, 15, 19 & 21) (Marginal) There is an ephemeral stream that is not delineated in the approved SWPPP adjacent to 1878+00 that does not have adequate controls in place. The SWPPP should be modified and additional BMPs installed in order to prevent sediment laden water from leaving the site.

Ephemeral stream adjacent to 1878+00 showing the need for modification of the approved SWPPP for additional BMPs. Marginal deficiencies in site evaluation item numbers 1, 13, 15, 19 & 21 pictured.

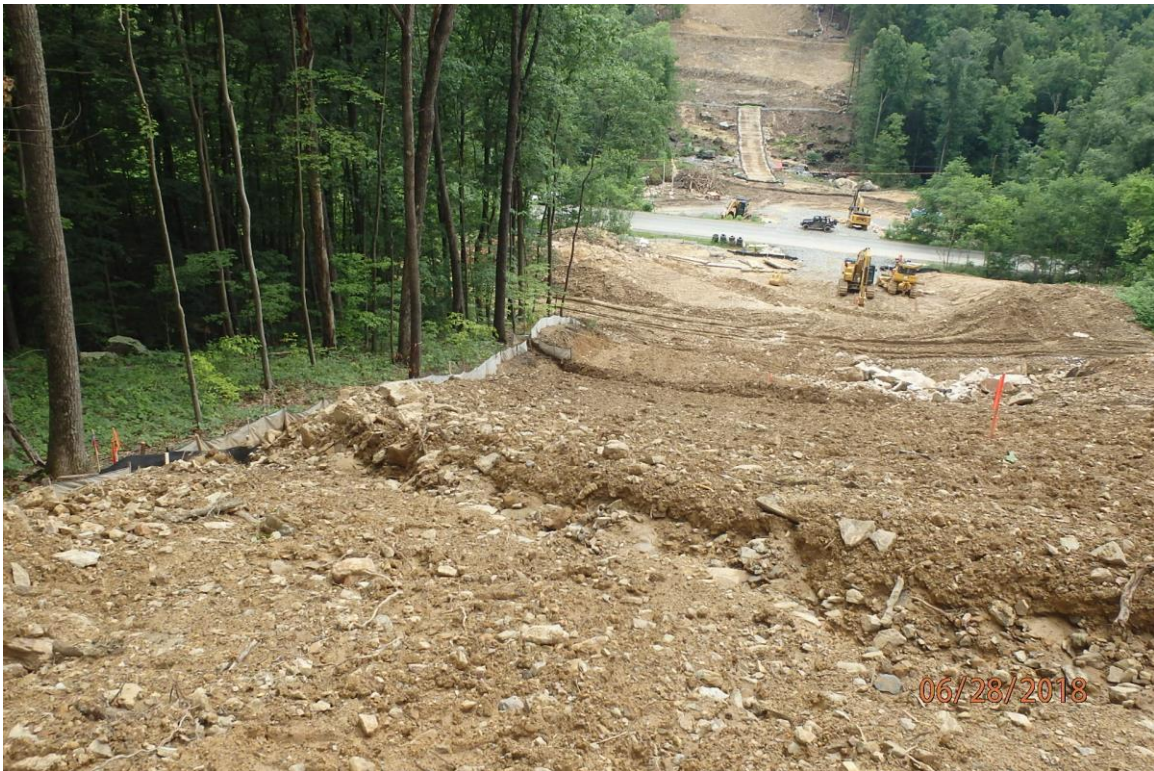
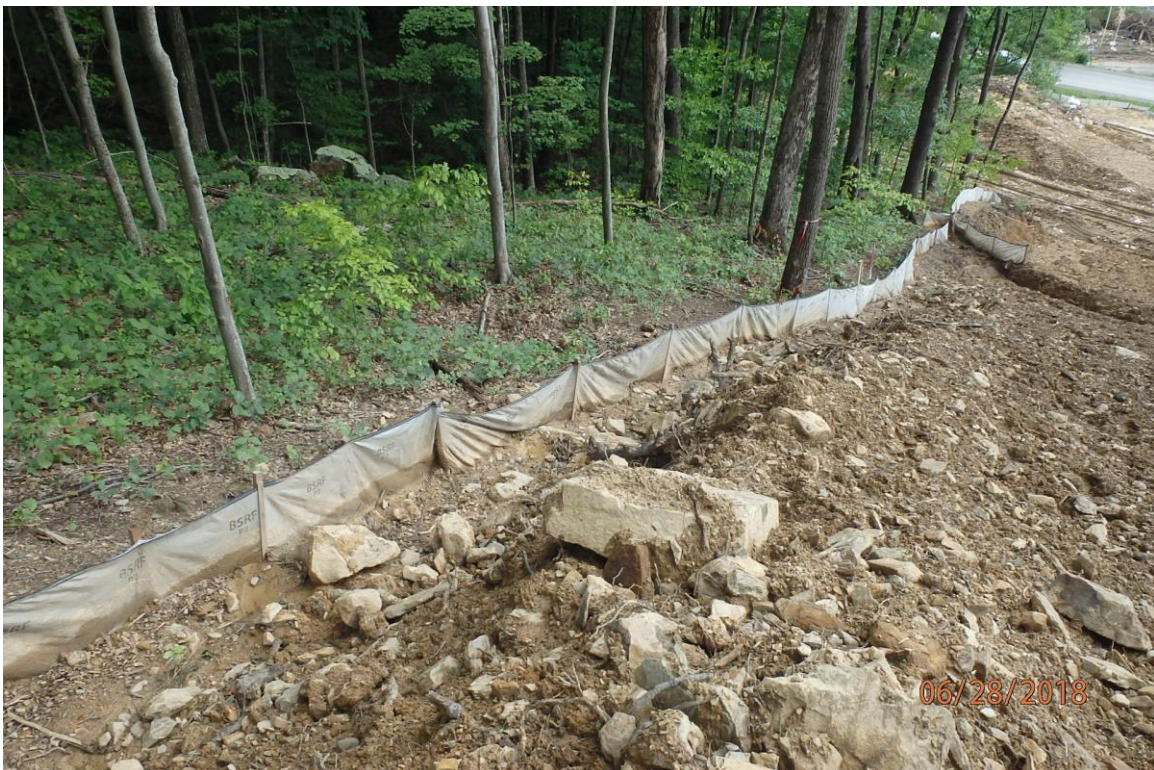
- 3). (7, 14 & 21) (Marginal) Temporary slope breakers did not extend past the installed perimeter silt fence from 1789+00 to 1794+00. The installed slope breakers did not shed stormwater off of the LOD as designed and caused concentrated flow to be directed over the fill slope.

Temporary slope breakers that do not extend past the installed perimeter silt fence from 1789+00 to 1794+00. Marginal deficiencies in site evaluation item numbers 7, 14 & 21 pictured.

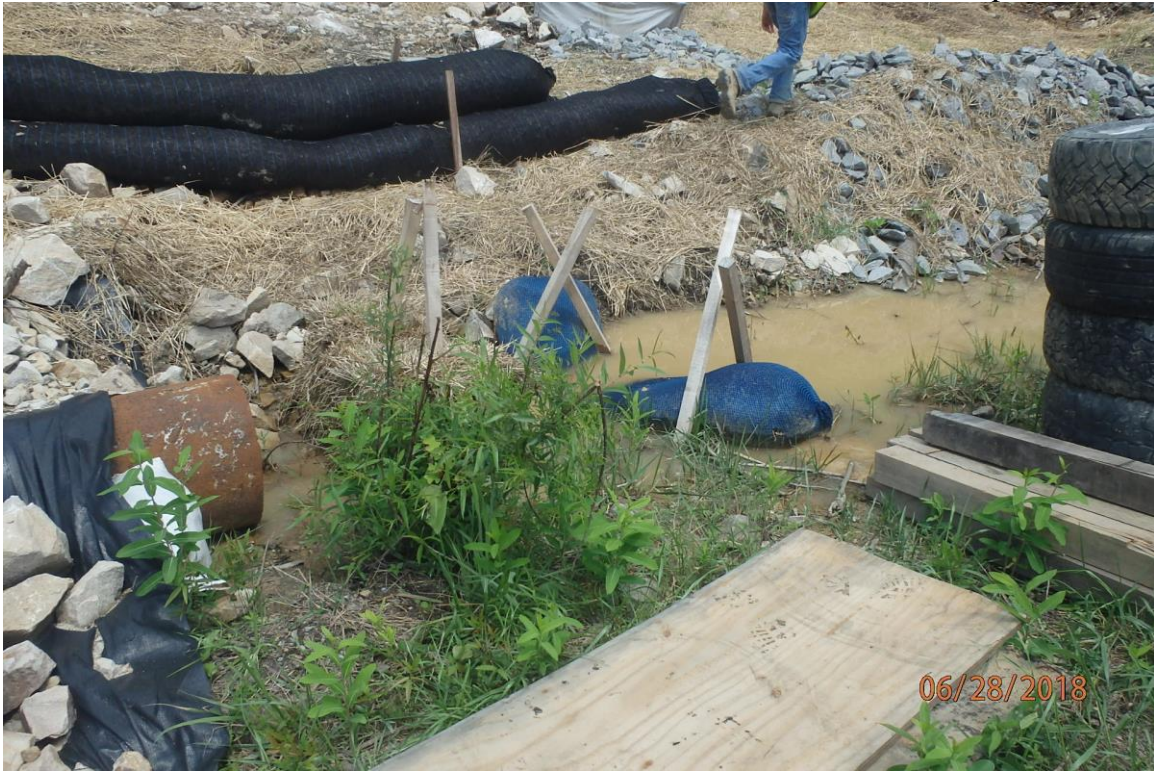
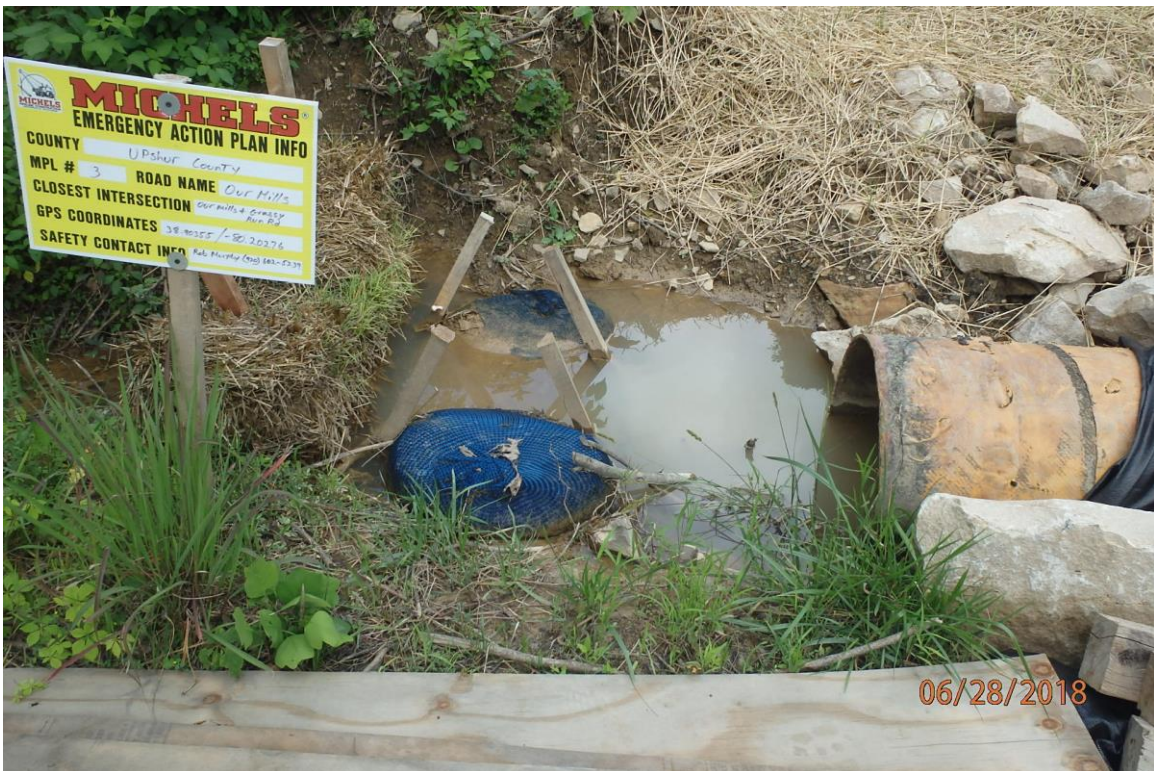
4). (2, 6, 19 & 20) The responsible party modified their plan and installed additional controls in the roadside ditch along Our Mills Road (1794+61). The installed controls (compost filter sock) were not properly operated, which allowed sediment laden water to bypass the installed BMP. Conditions Not Allowable (CNA) deposits were noted in ephemeral UNT Grassy Run (Offsite) (38° 54.205' X 80° 12.194') as a result.

**1. Section D.1.- failed to operate and maintain all erosion control devices. Compost filter sock was installed in the roadside ditch along Our Mills Road (1974+61). The installed BMP was not properly operated, which allowed sediment laden water to bypass the BMP.**

Installed compost filter sock in the roadside ditch along Our Mills Road (1974+61) that is not being properly operated. Deficiencies in site evaluation item numbers 2, 6, 19 & 20 pictured.

**Take measures to correct the aforementioned violations.**

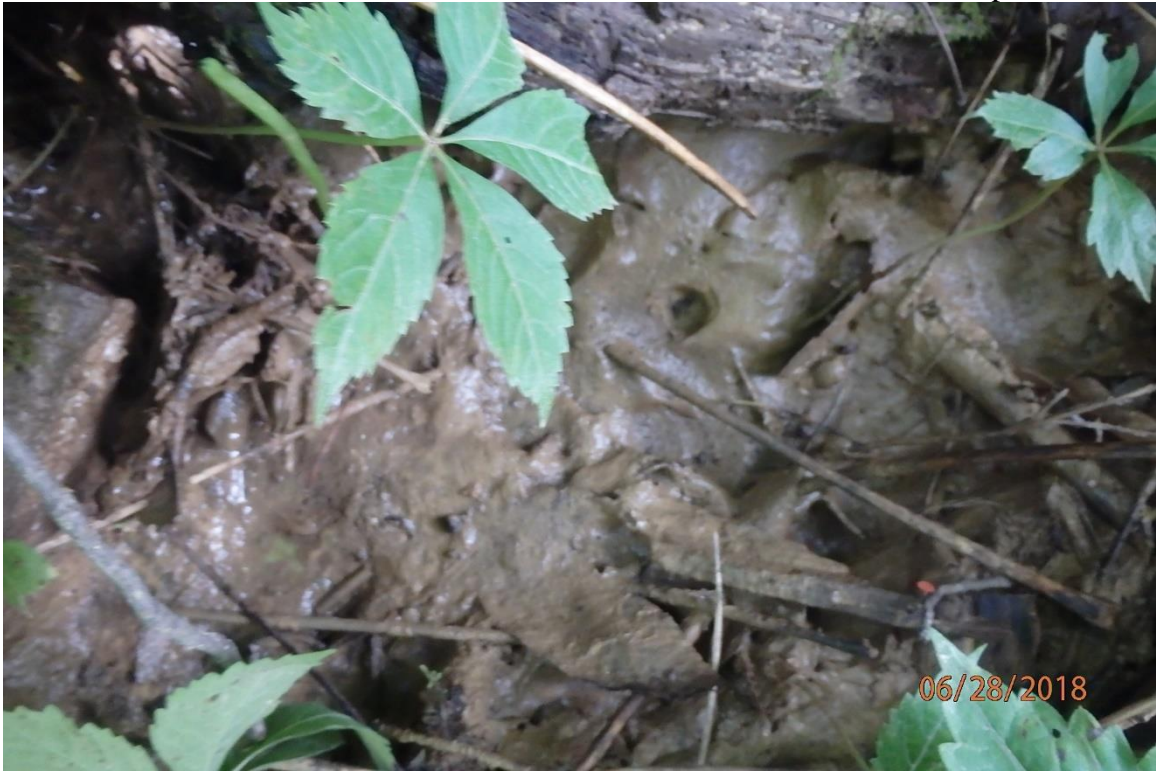
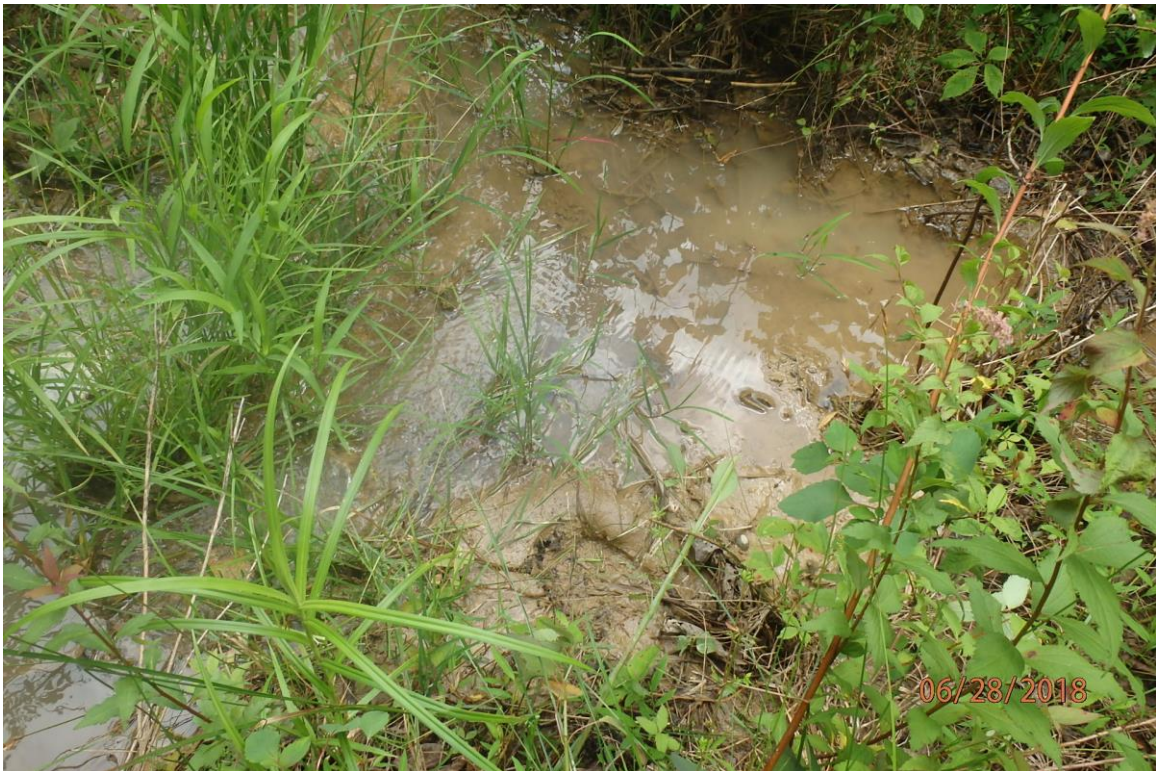
**3. Title 47, Series 2, Section 3.2.b.-Caused conditions not allowable in waters of the State by allowing sediment deposits on the bottom of UNT Grassy Run (38° 54.205' X 80° 12.194').**

Offsite sediment deposits in UNT Grassy Run (38° 54.205' X 80° 12.194') that originate from the site. Deposits originate from roadside ditch along Our Mills Road. Deficiencies in site evaluation item numbers 19 & 20 pictured.

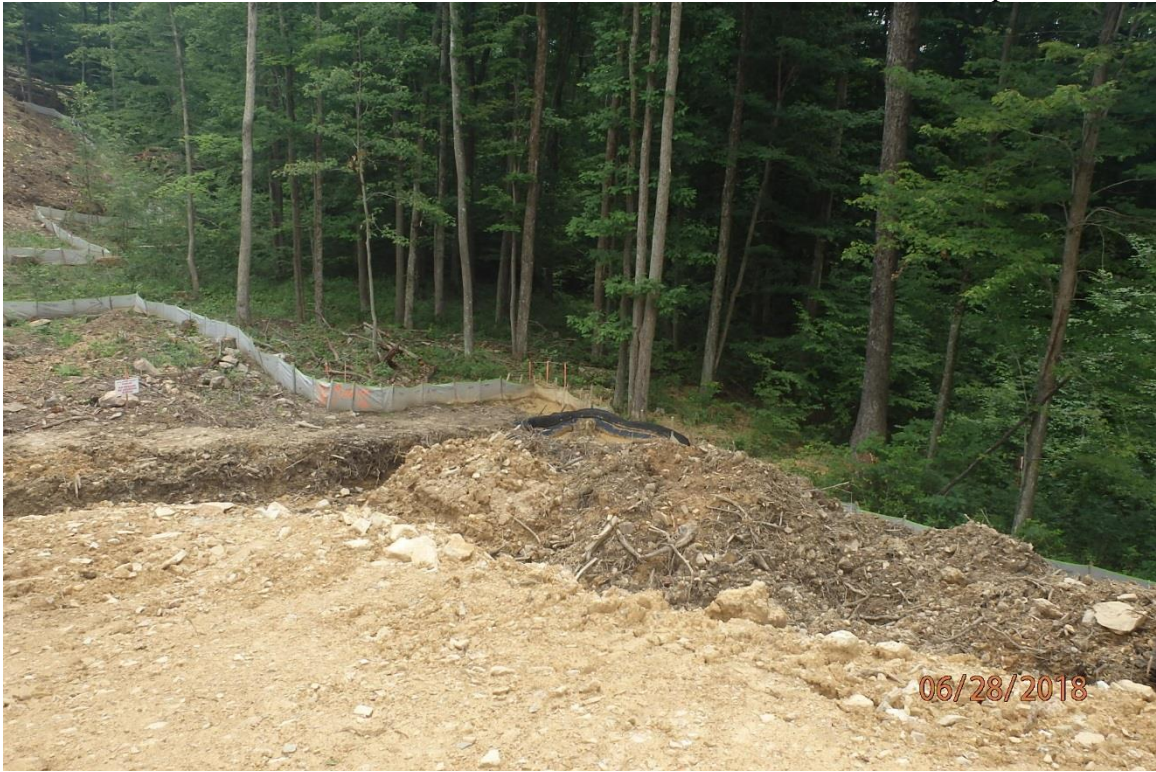
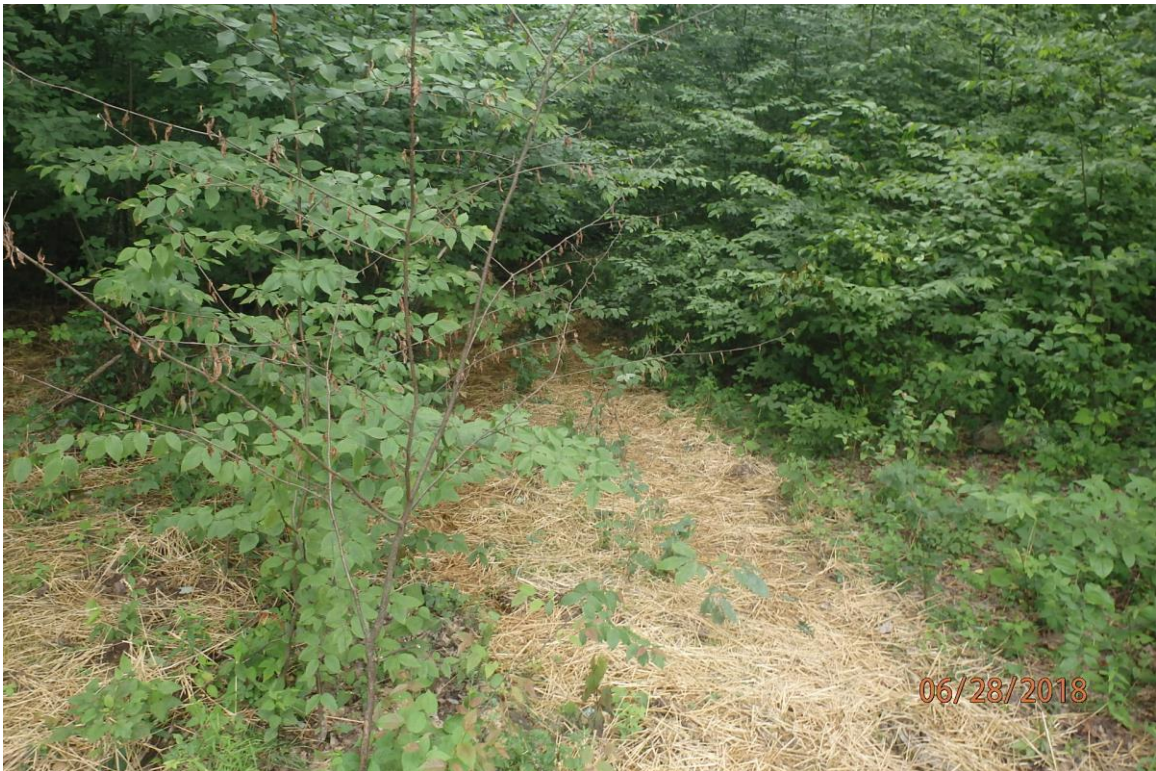
5). (6, 7, 14, 19 & 21) Temporary slope breakers that were installed at steep angles were noted in areas scattered throughout the inspected area. This condition caused excessive erosion of the fill slope at the BMP. The sediment produced by the erosion caused the installed treatment at the terminus of the slope breakers to be overwhelmed. Offsite sediment deposits were noted as a result. The responsible party had seeded and mulched a portion of the offsite sediment deposits, but they had failed to correct the cause of the erosion.

Temporary slope breaker terminus treatment that has been overwhelmed due to excessive erosion at the slope breaker and the associated offsite sediment deposits in the UNT Buckhannon River watershed.

Deficiencies in site evaluation item numbers 6, 7, 14, 19 & 21 pictured.

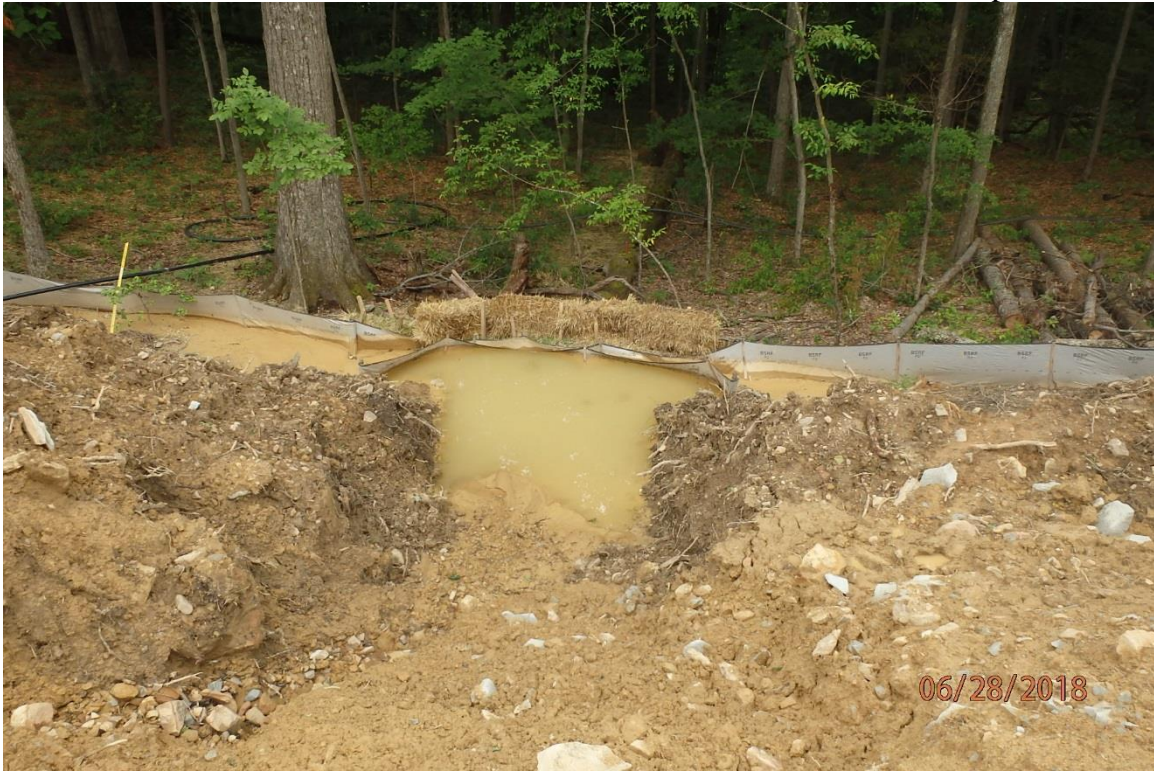
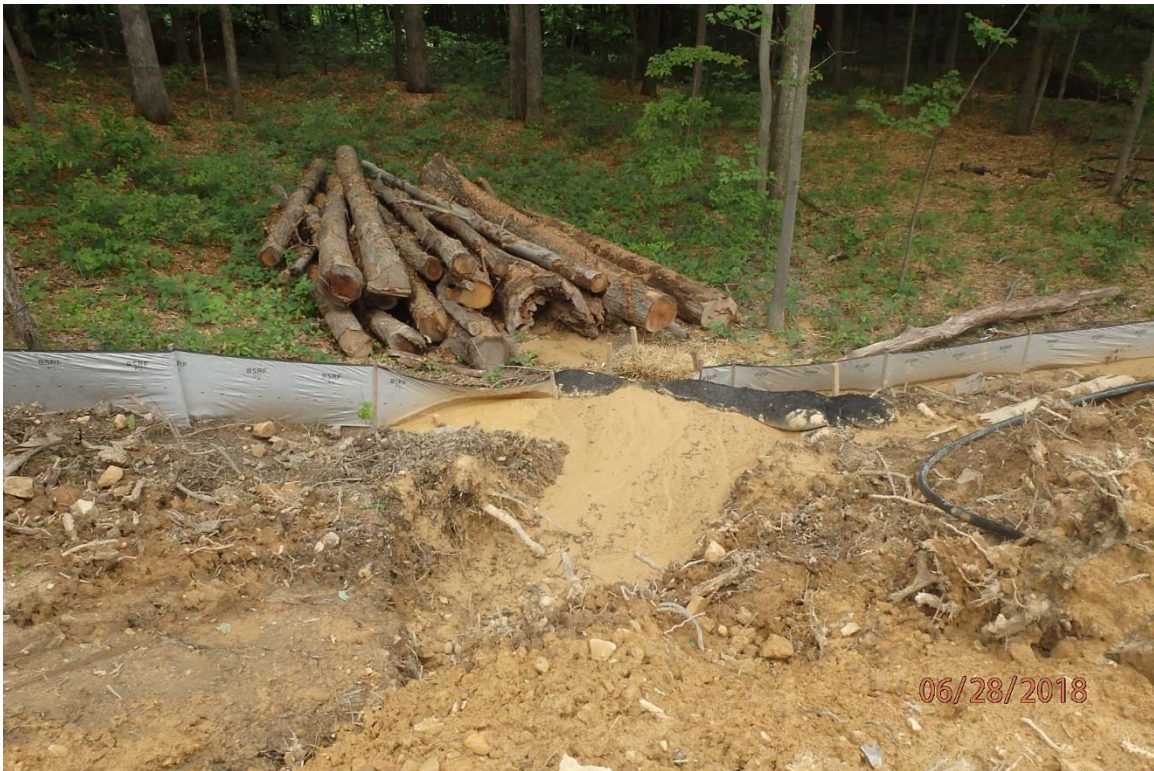
Temporary slope breaker terminus treatment that has been overwhelmed due to excessive erosion at the slope breaker and the associated offsite sediment deposits in the UNT Buckhannon River watershed. Deficiencies in site evaluation item numbers 6, 7, 14, 19 & 21 pictured.

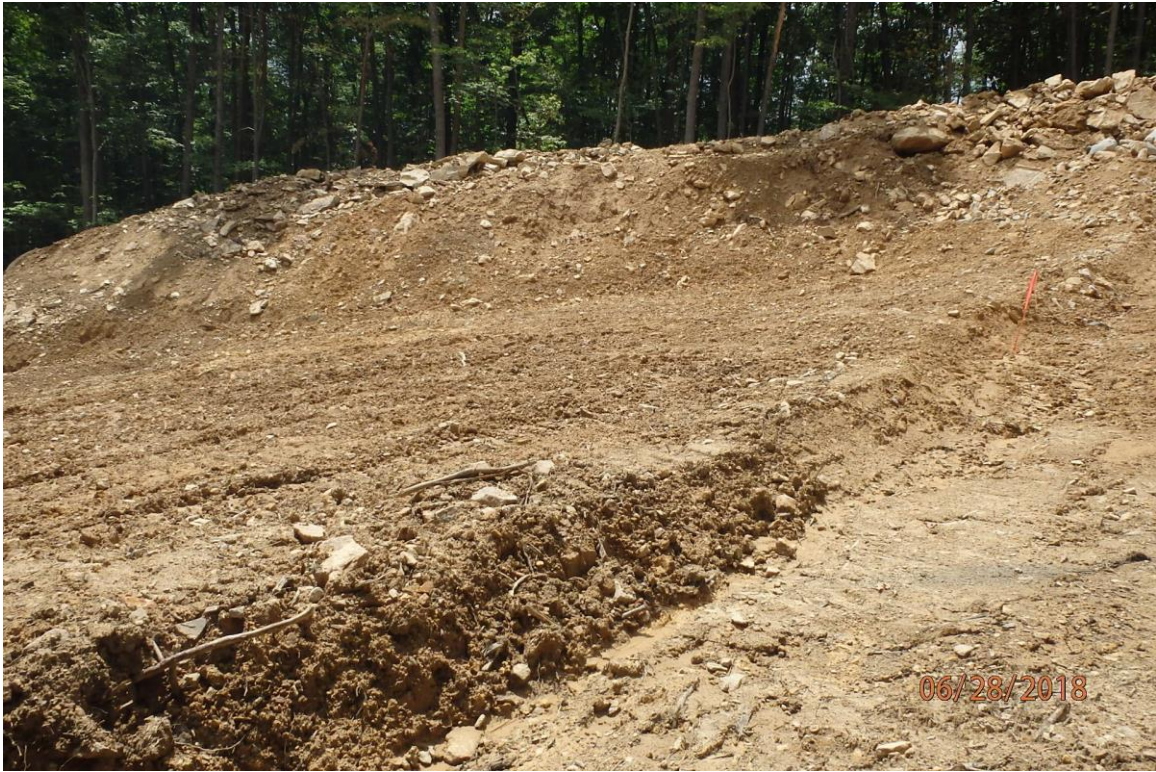
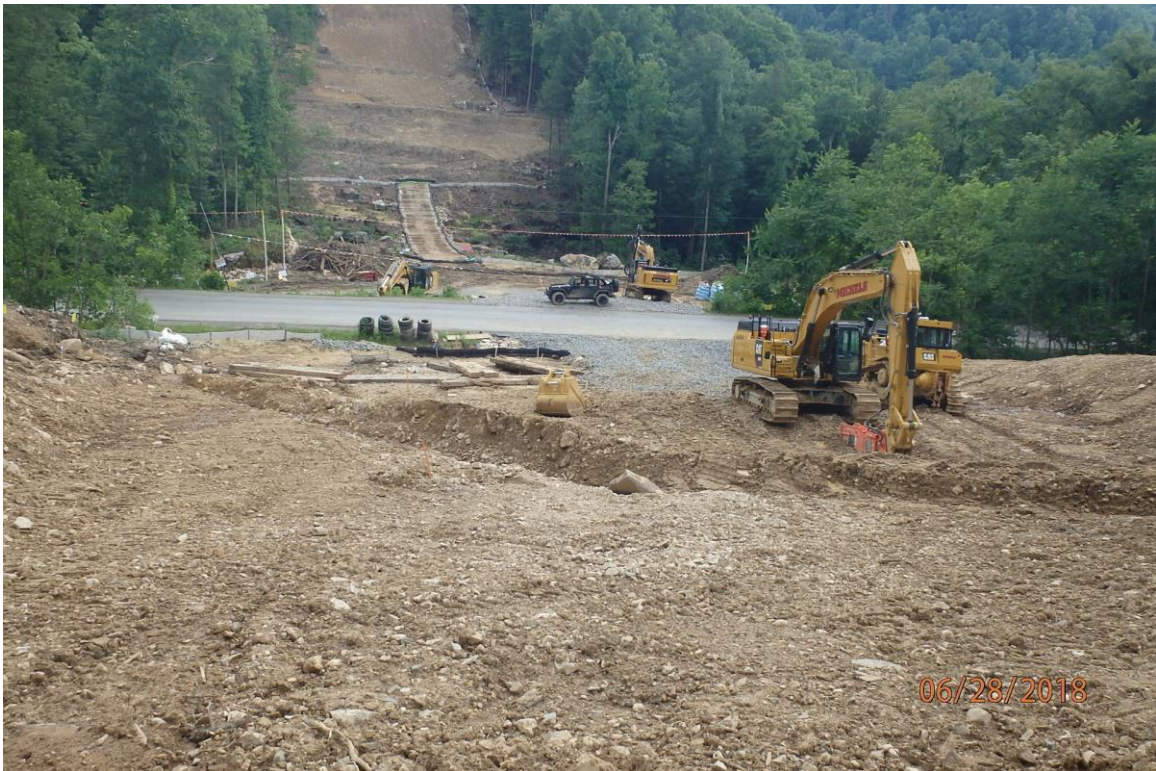
**Temporary slope breakers were not properly operated in areas scattered throughout the inspected area. The slope breakers were installed at steep angles, which caused excessive erosion of the fill slope at the BMP.**

Temporary slope breakers that are installed at a steep angle in the Grassy Run watershed. Deficiencies in site evaluation item numbers 6, 7, 14, 19 & 21 pictured.

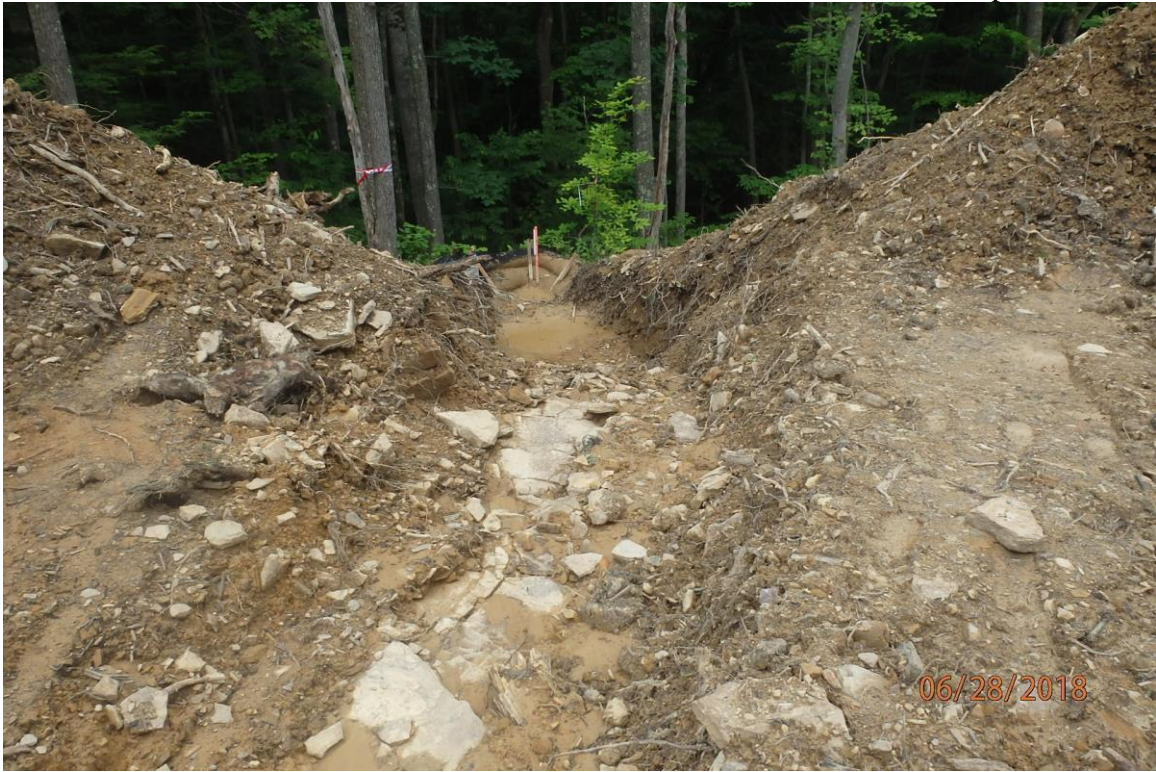
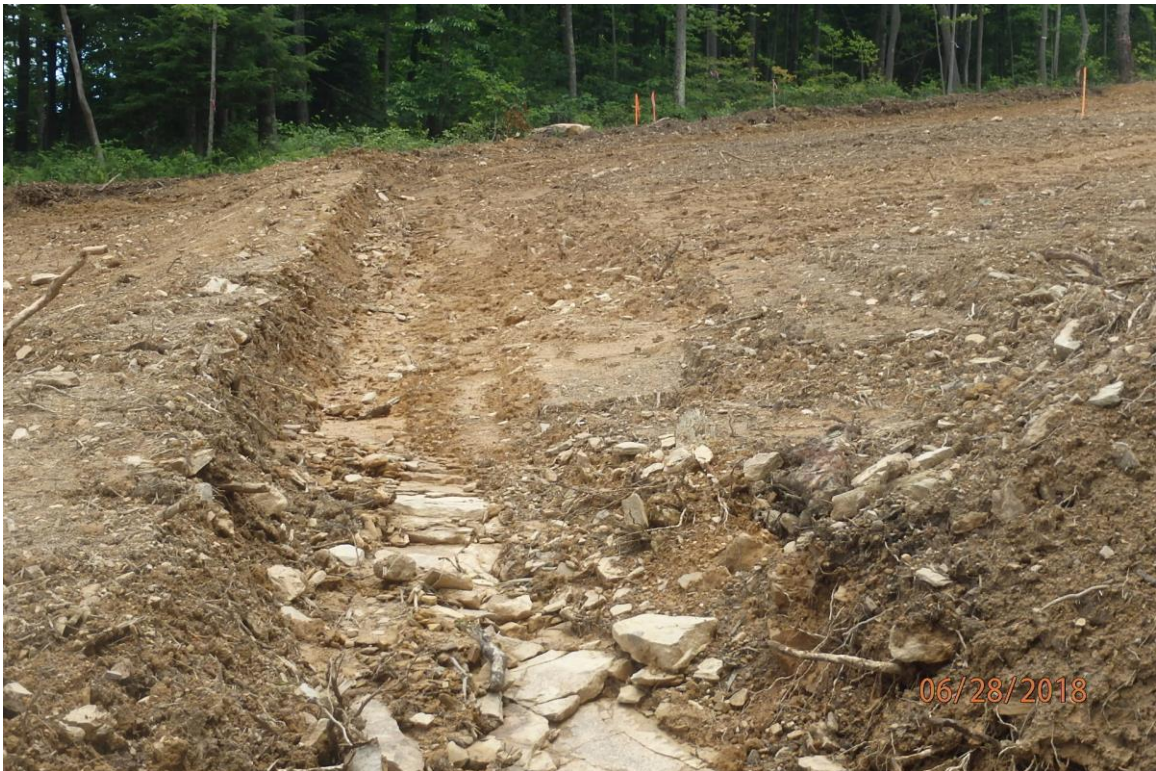
Temporary slope breakers that are installed at a steep angle in the Buckhannon River watershed showing excessive erosion. Deficiencies in site evaluation item numbers 6, 7, 14, 19 & 21 pictured.
