Allegheny-Blue Ridge Alliance

RE: CPF 1-2019-1014W Warning Letter – Additional Info

Possible Construction Problem Areas – Atlantic Coast Pipeline

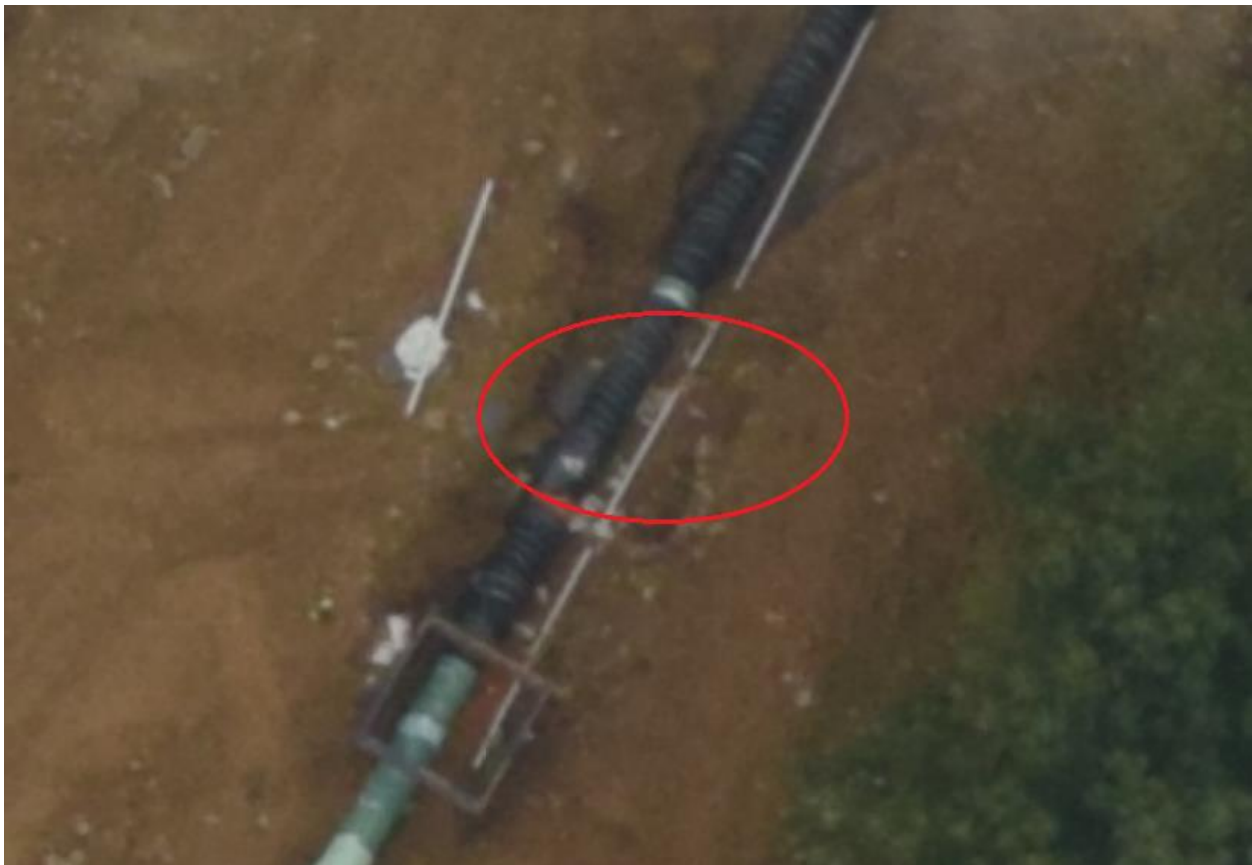
8/22/2018 1156 MP 31.6 -80.228532, 38.924219

5,4 Possible rock(s) in contact with pipe in trench.

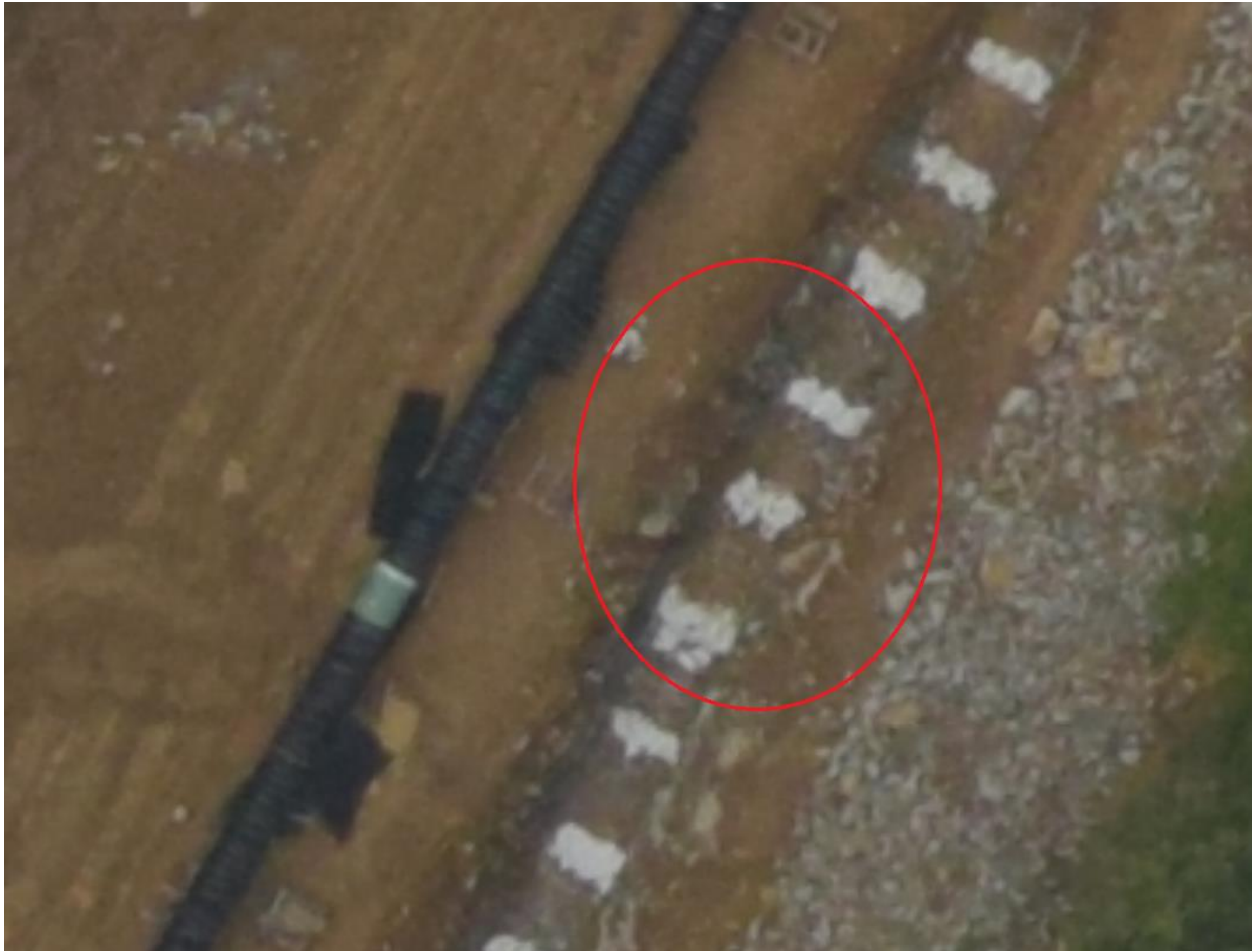
8/22/2018 1146 MP 32.02 -80.221906, 38.923183

3,4 Bedrock visible in trench. Rock in trench. Pipe NOT in trench. But possible problem area.

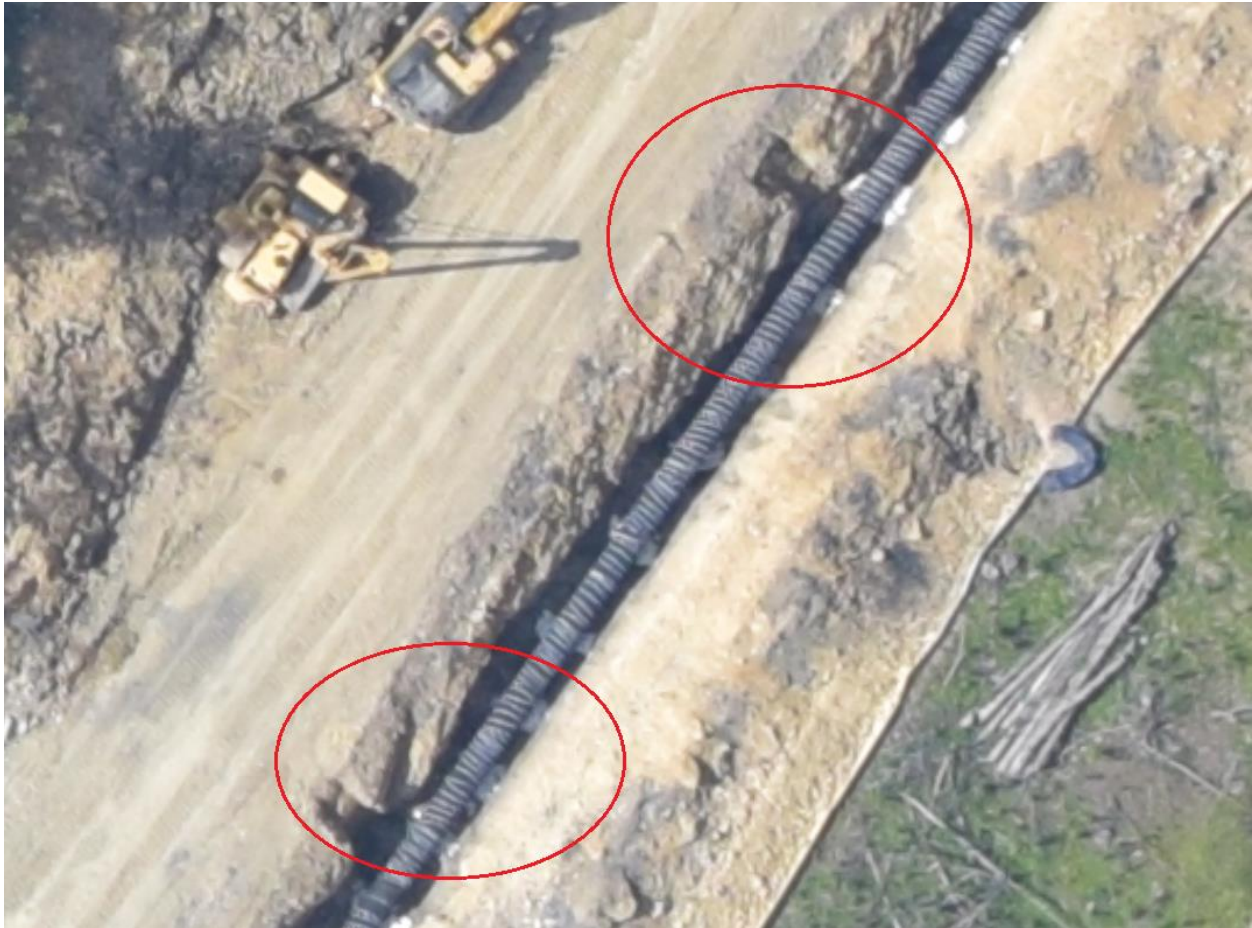
9/5/2018 976 MP 32.5 -80.215180, 38.919136

7,4 Possible large, sharp pieces of bedrock jutting into trench, ~1ft from pipe. May be compacted soils.

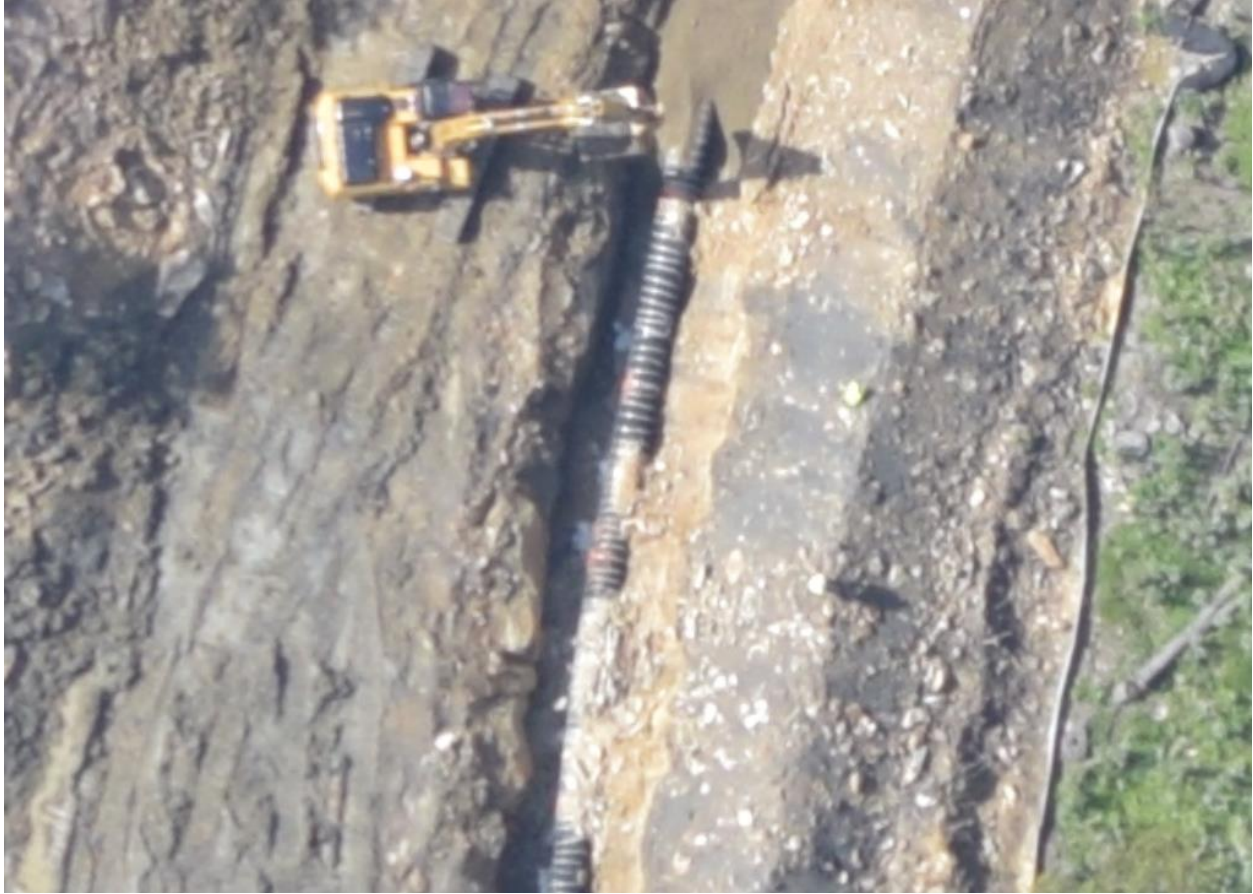
9/19/2018 1149 MP 32.53 -80.214378, 38.919136

5,5 Rocks under, surrounding, on top of pipe in trench. Foam(?) supports under pipe. Active filling of trench.

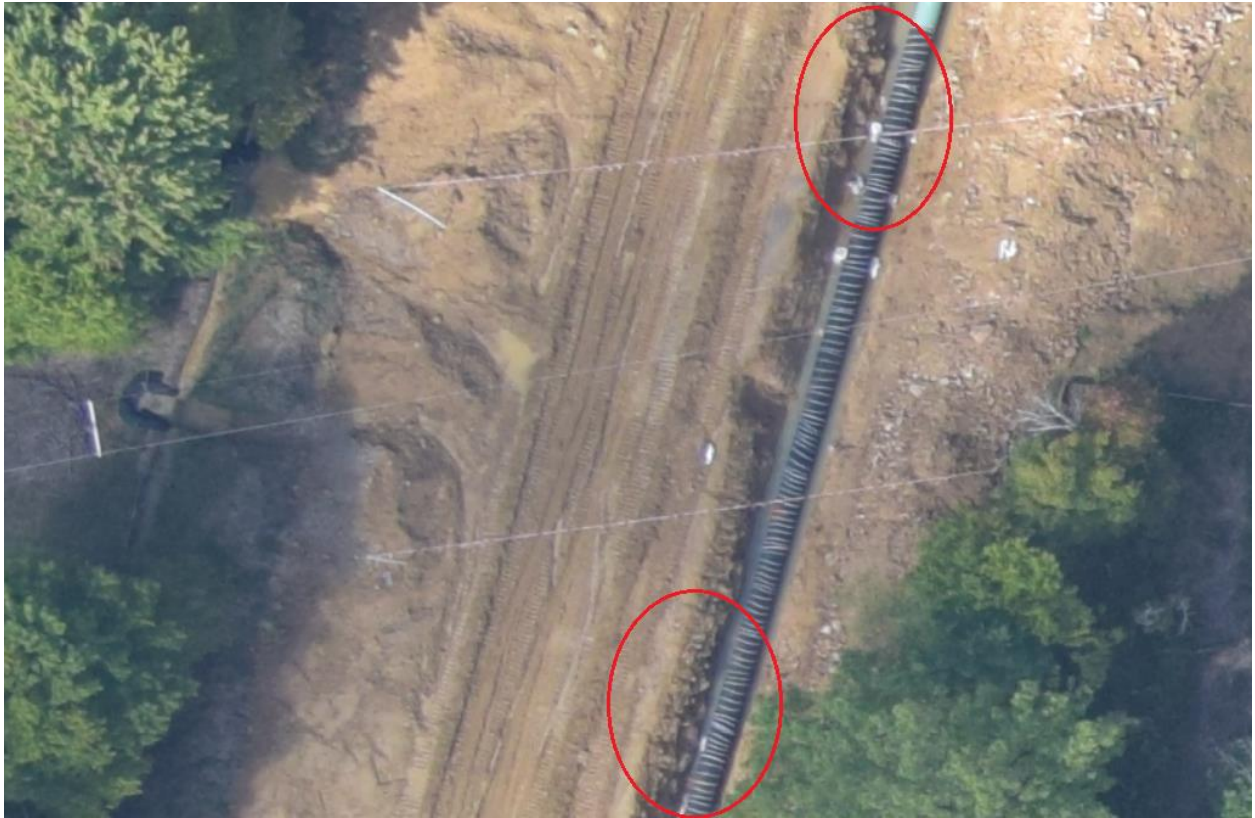
9/19/2018 1140 MP 32.93 -80.208432, 38.919796

1,6; 2;7 Large rocks jutting out of trench wall.

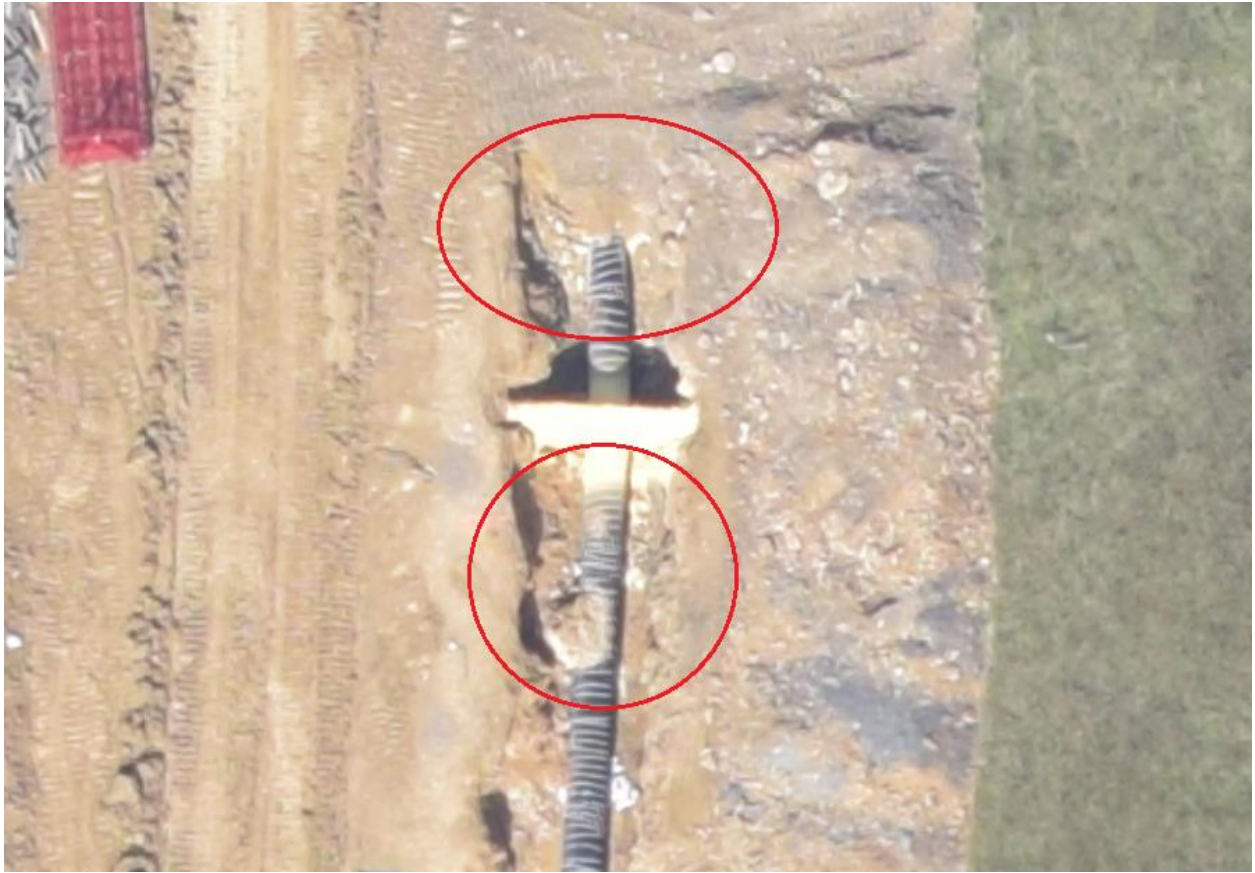
9/19/2018 1135 MP 33.1 -80.206711, 38.917928

3,8 Upper end of trench. Large rocks surrounding pipe.

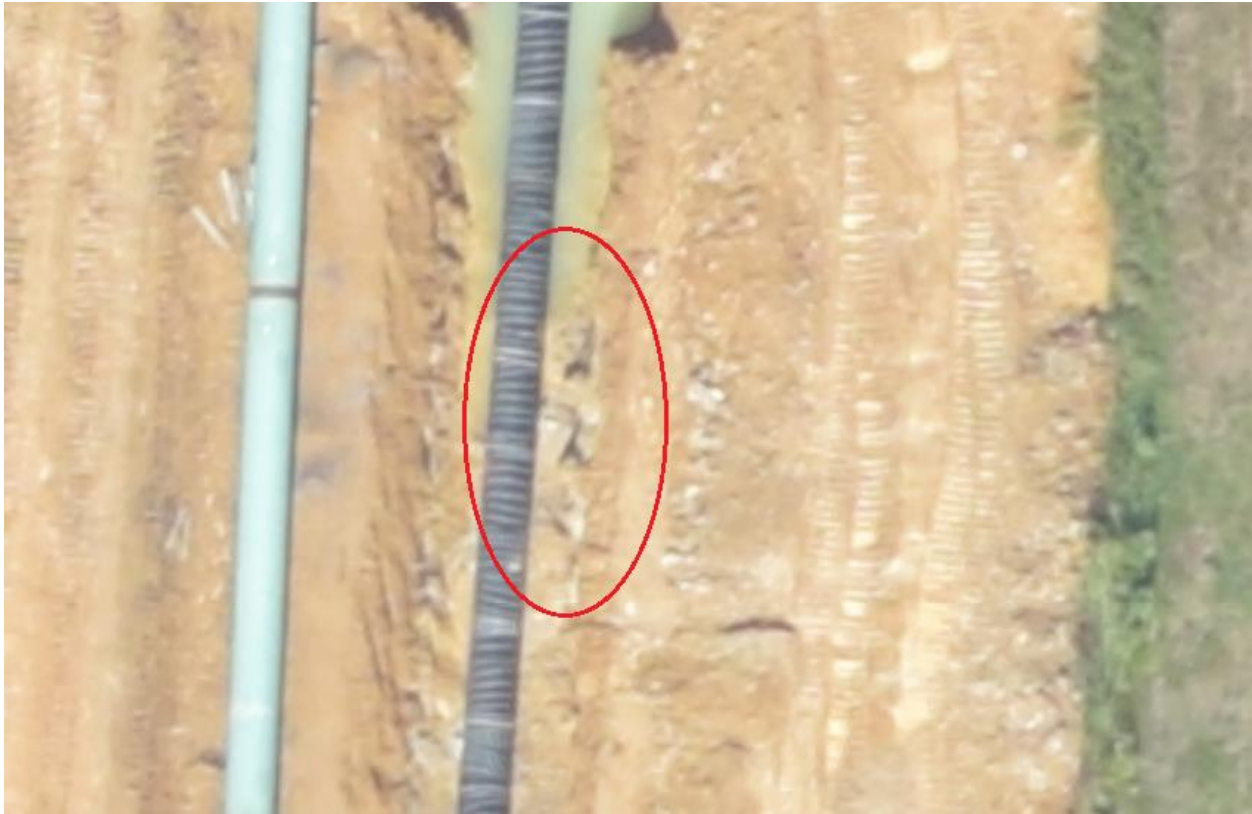
9/19/2018 1125 MP 33.63 -80.204361, 38.910679

3,6 Just below the water, two rocks, large enough to cast shadows, sit in the trench to the right of the pipe. Lots of other boulder-or-bigger rocks visible along trench.

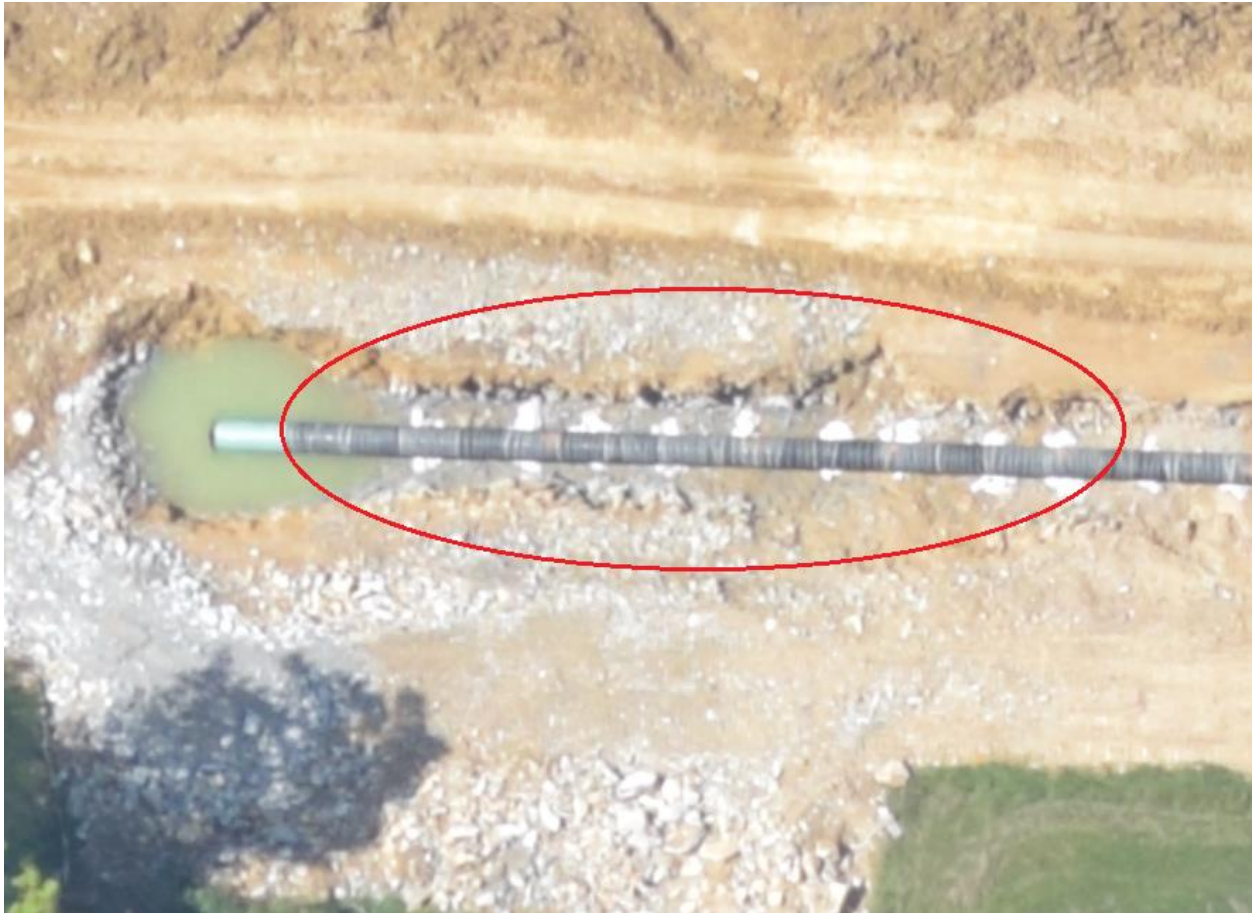
9/19/2018 1122 MP 33.8 -80.203613, 38.908424

5,5 Shattered bedrock lines the trench.

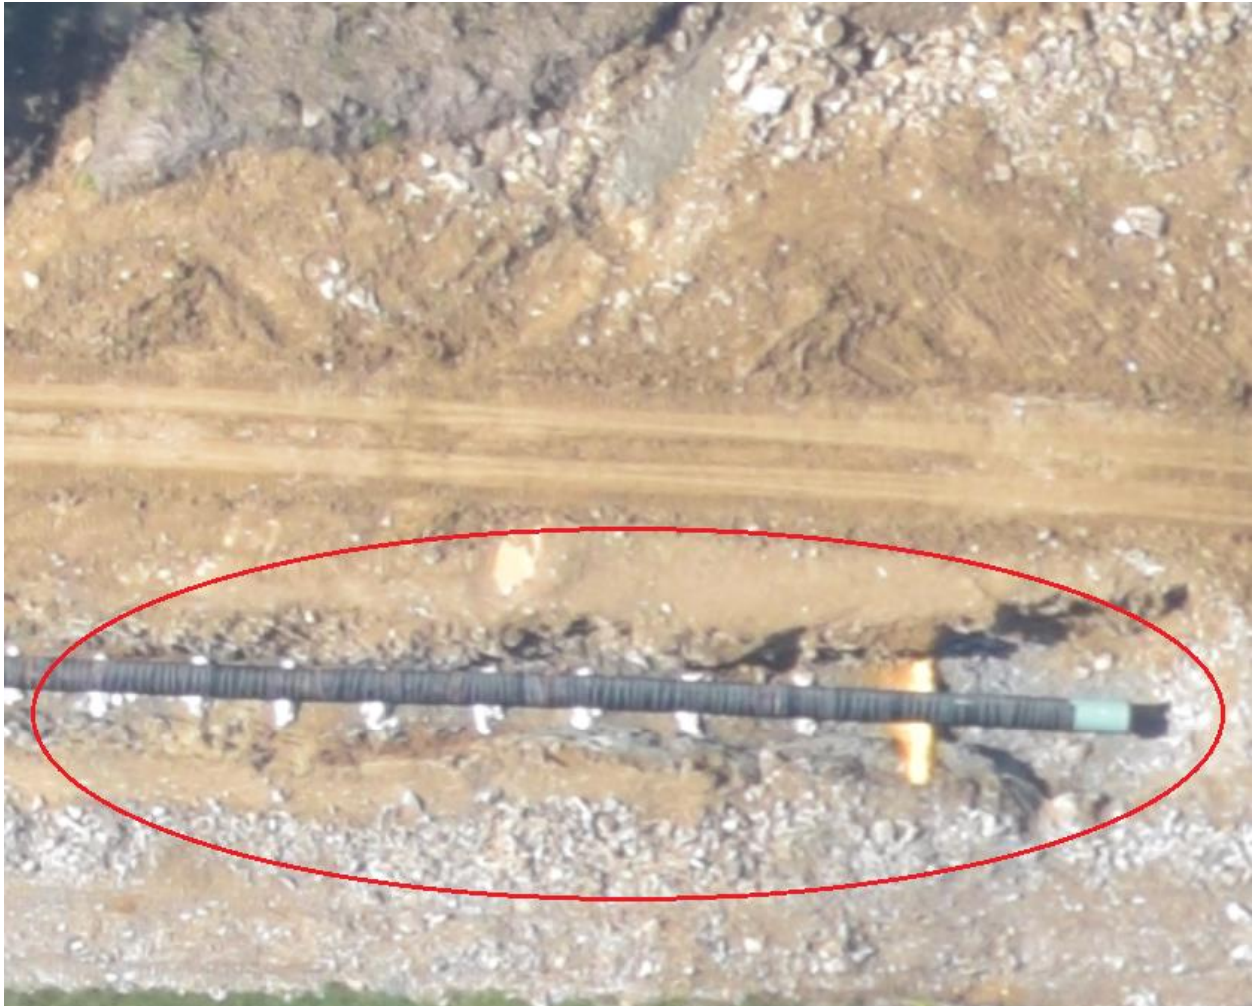
9/19/2018 1122 MP 33.85 -80.203325, 38.907572

5,1 Shattered bedrock lines the trench.

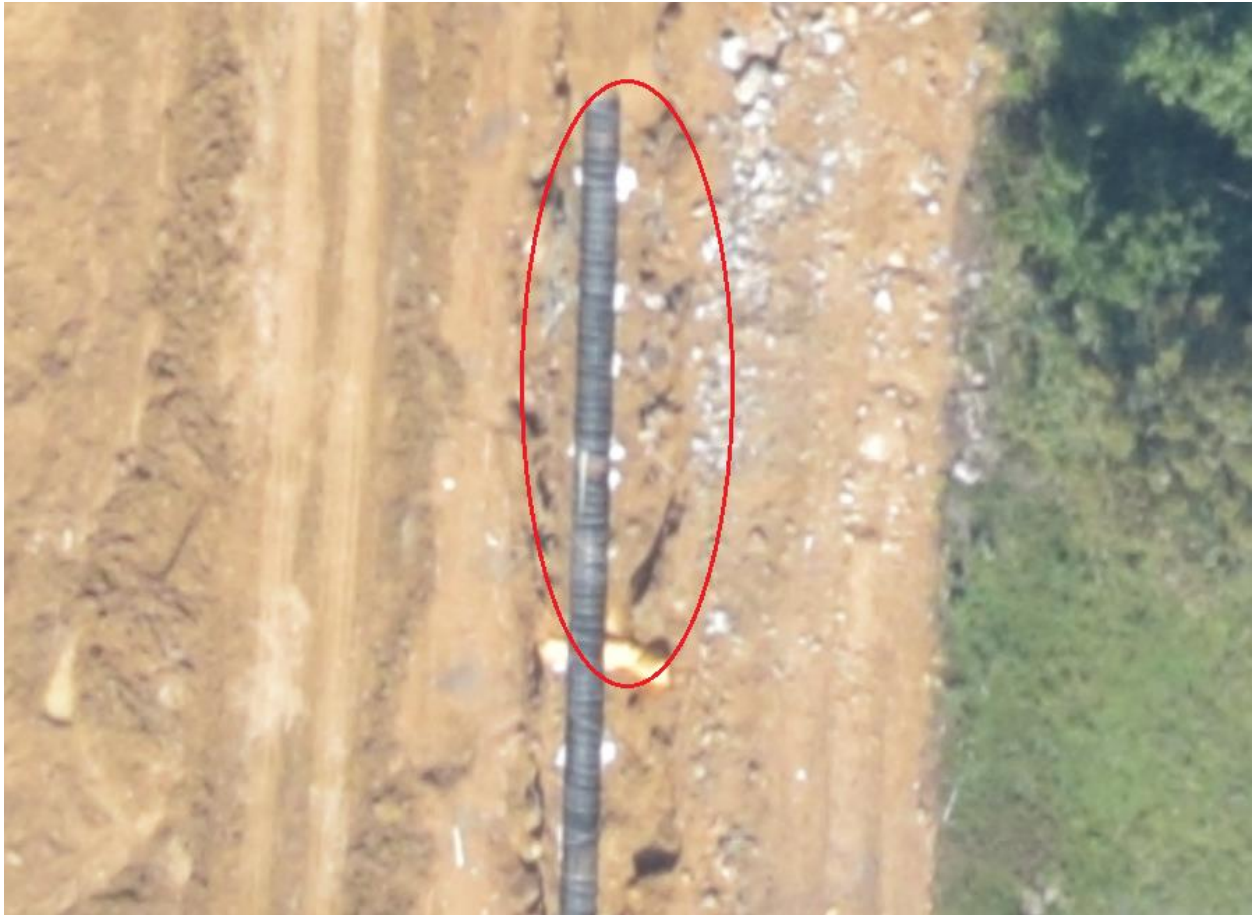
9/19/2018 1119 MP 33.95 -80.202791, 38.906005

6,5 Many large rocks in the trench with the pipe.

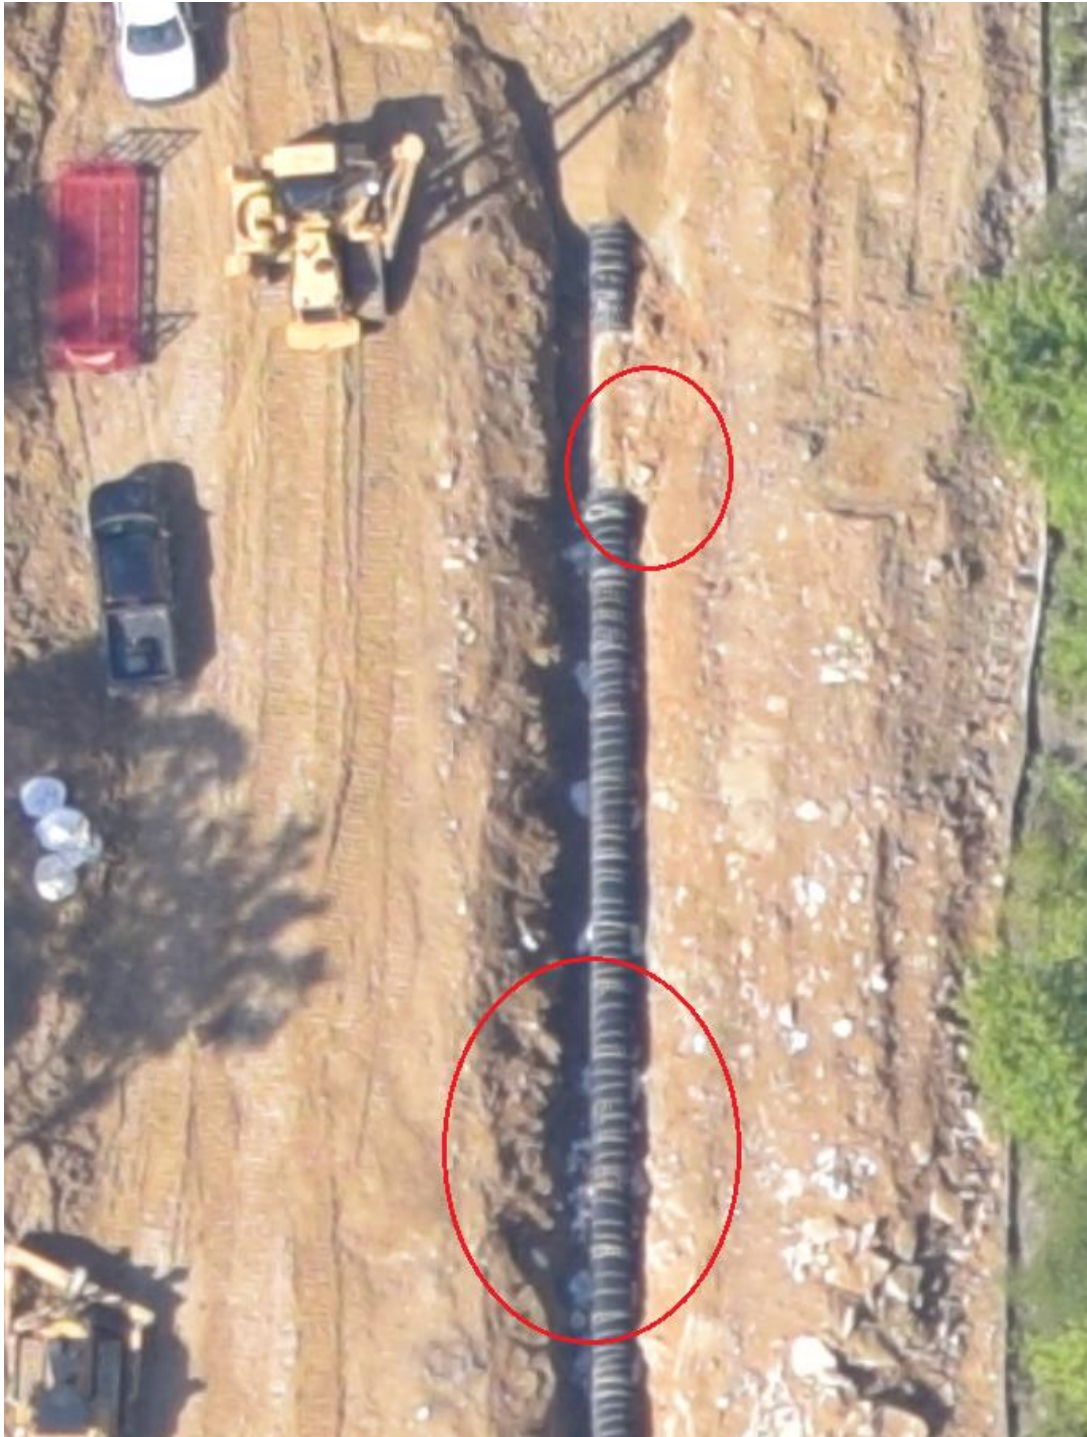
9/19/2018 1109 MP 34.48 -80.200574, 38.900071

3,7 Large rocks (jagged bedrock) jutting out of trench wall.; 3,8 Rocks in fill on top of pipe;

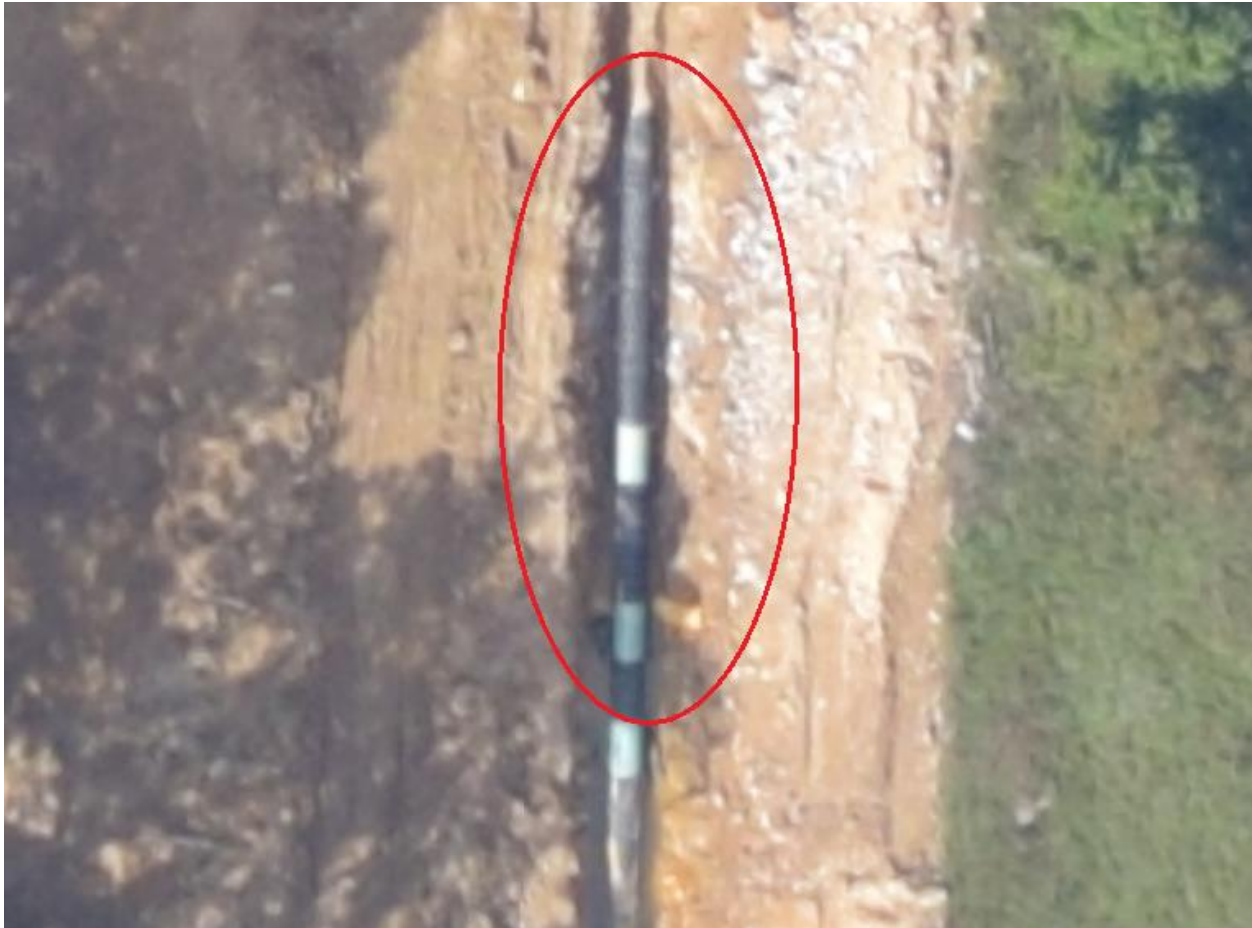
10/8/2018 1330 MP 33.9+/- -80.203345, 38.907729

6,3 Rock-lined trench. 6,7-6,8 Excavators either filling with rocky soil or digging rocks from around placed pipe.

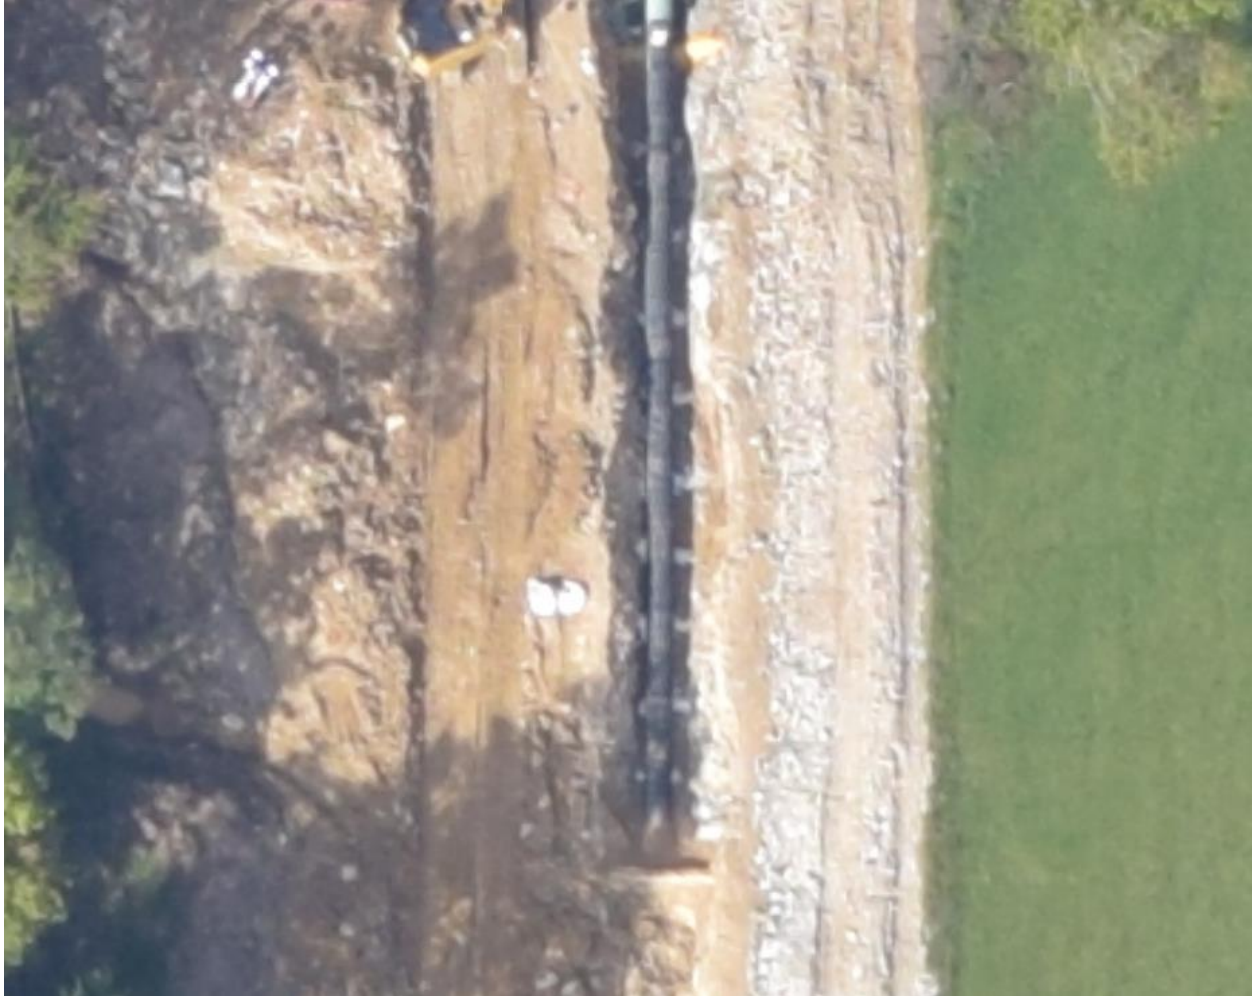
10/8/2018 1330 MP 33.9+/- -80.203345, 38.907729

6,7 Rock-lined trench.

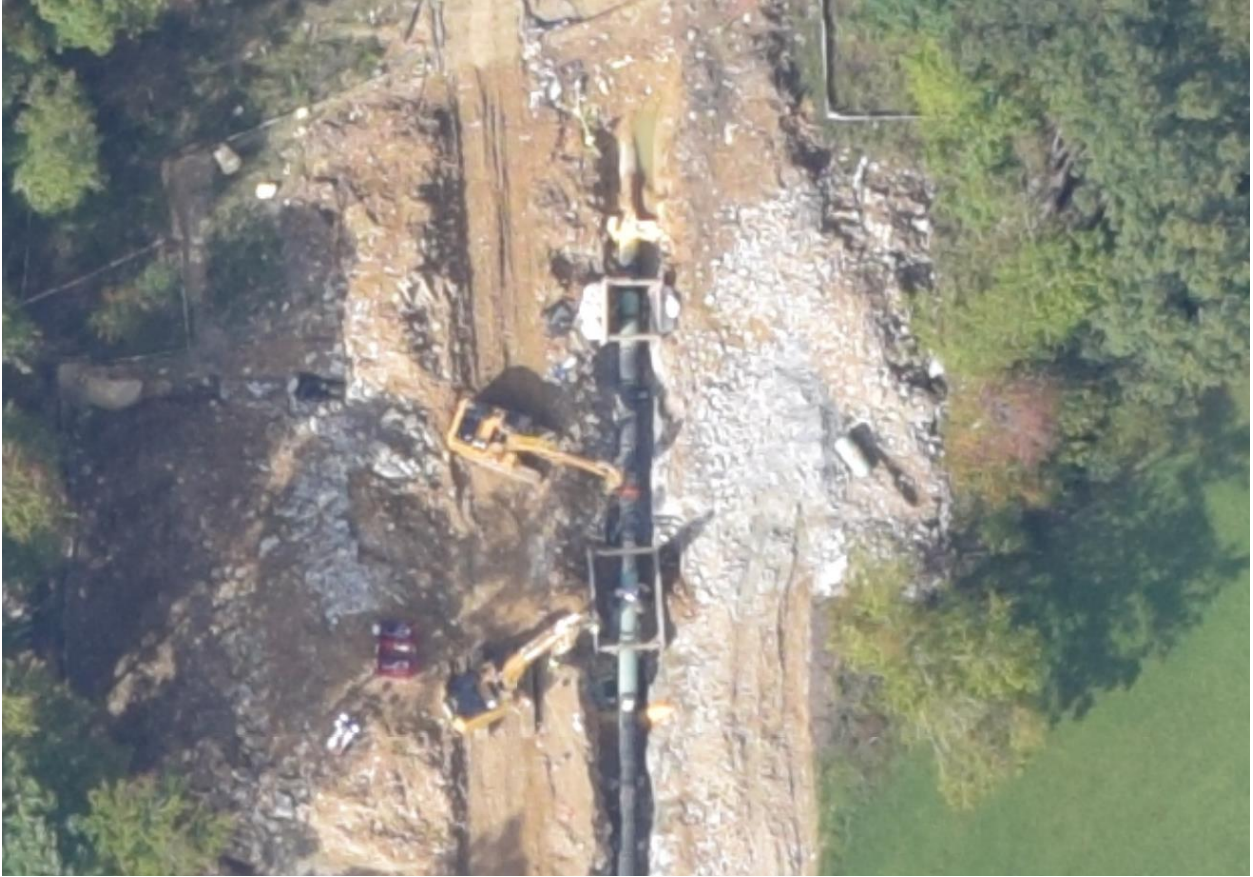
10/8/2018 1330 MP 33.9+/- -80.203345, 38.907729

6,8 Excavators either filling with rocky soil or digging rocks from around placed pipe.

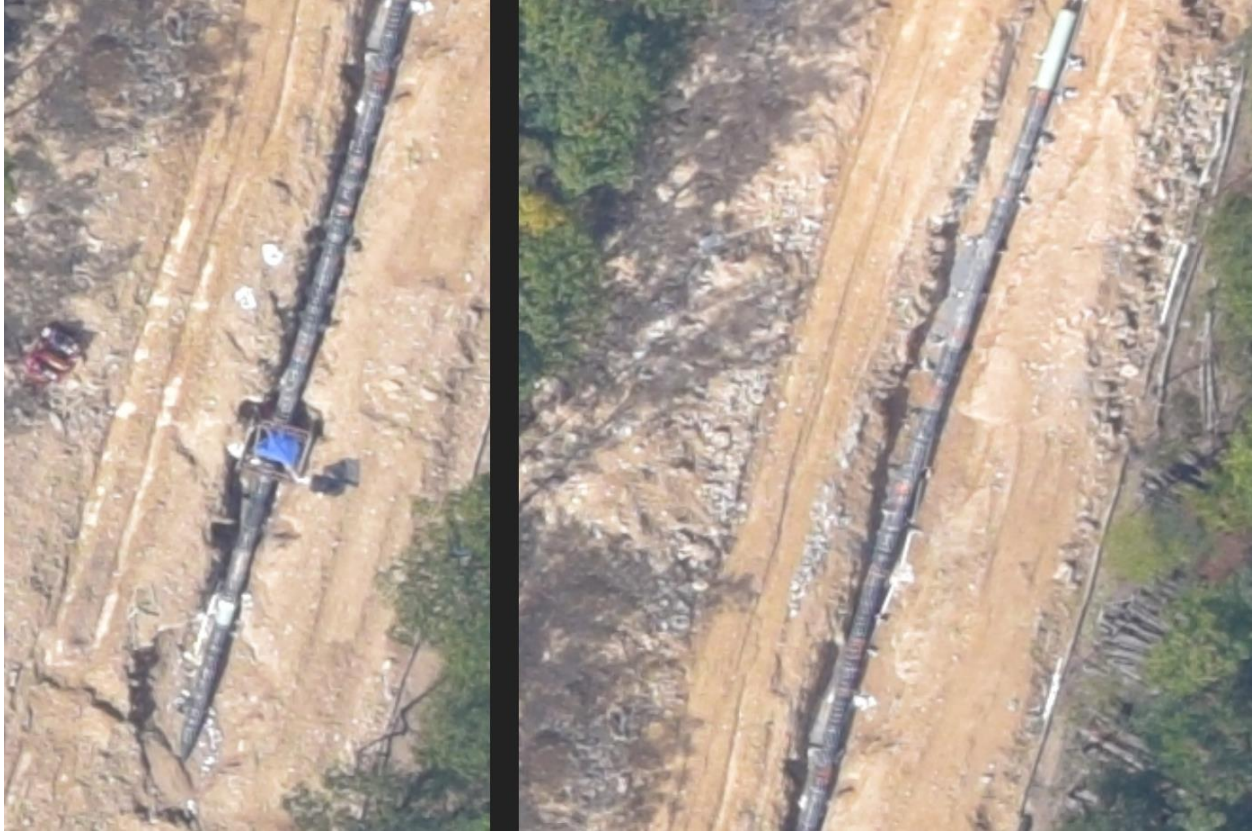
10/8/2018 1328 MP 34.06 -80.202660, 38.904767

8,4 Rocks and debris in trench as pipe daylights. Thru 8,6 Appears to be various types of debris in trench with pipe.

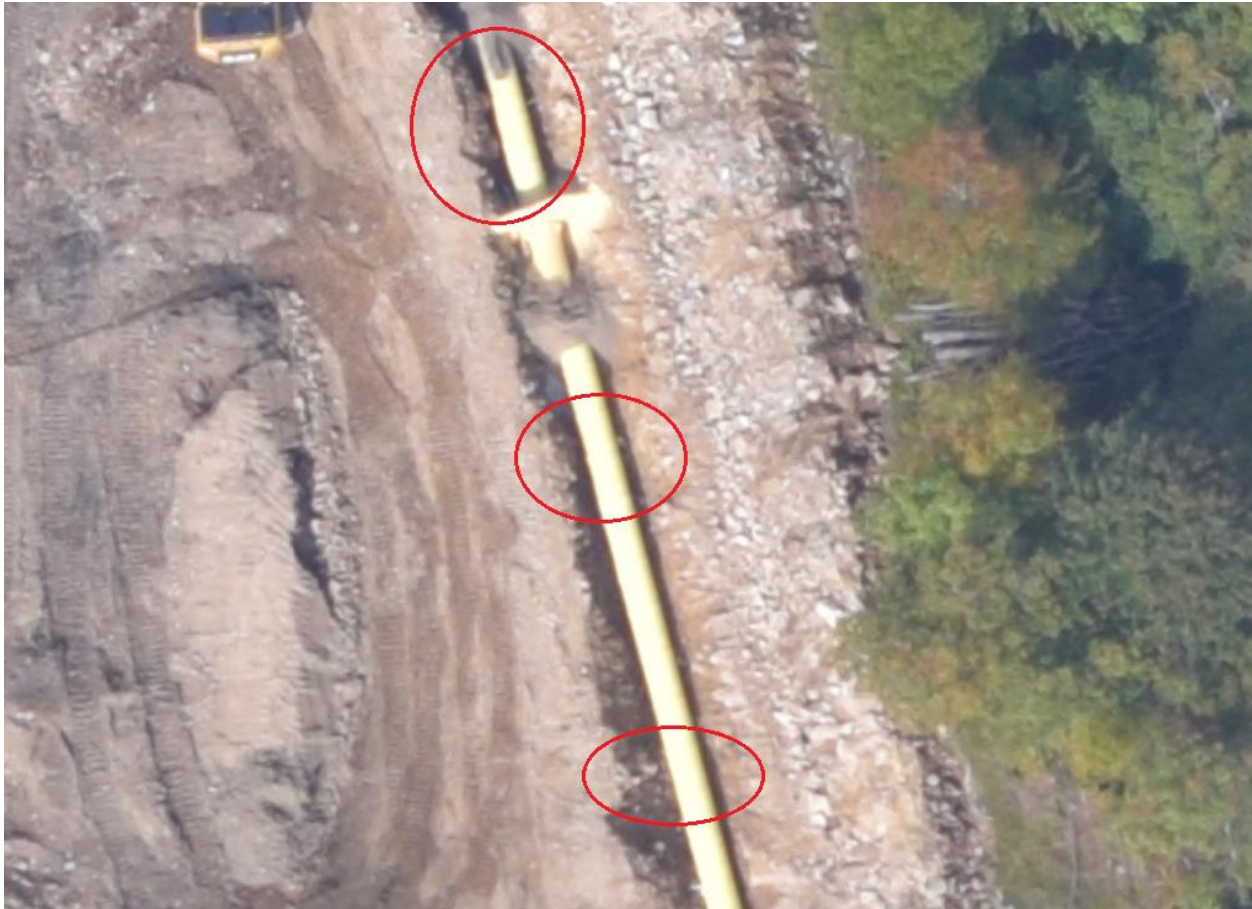
10/8/2018 879 MP 64.9 -80.137605, 38.558797

4,4; 4,6 Possible AOC - appears to be rocks or debris in trench under pipe; Bedrock jutting into trench w/in ~1ft of pipe.

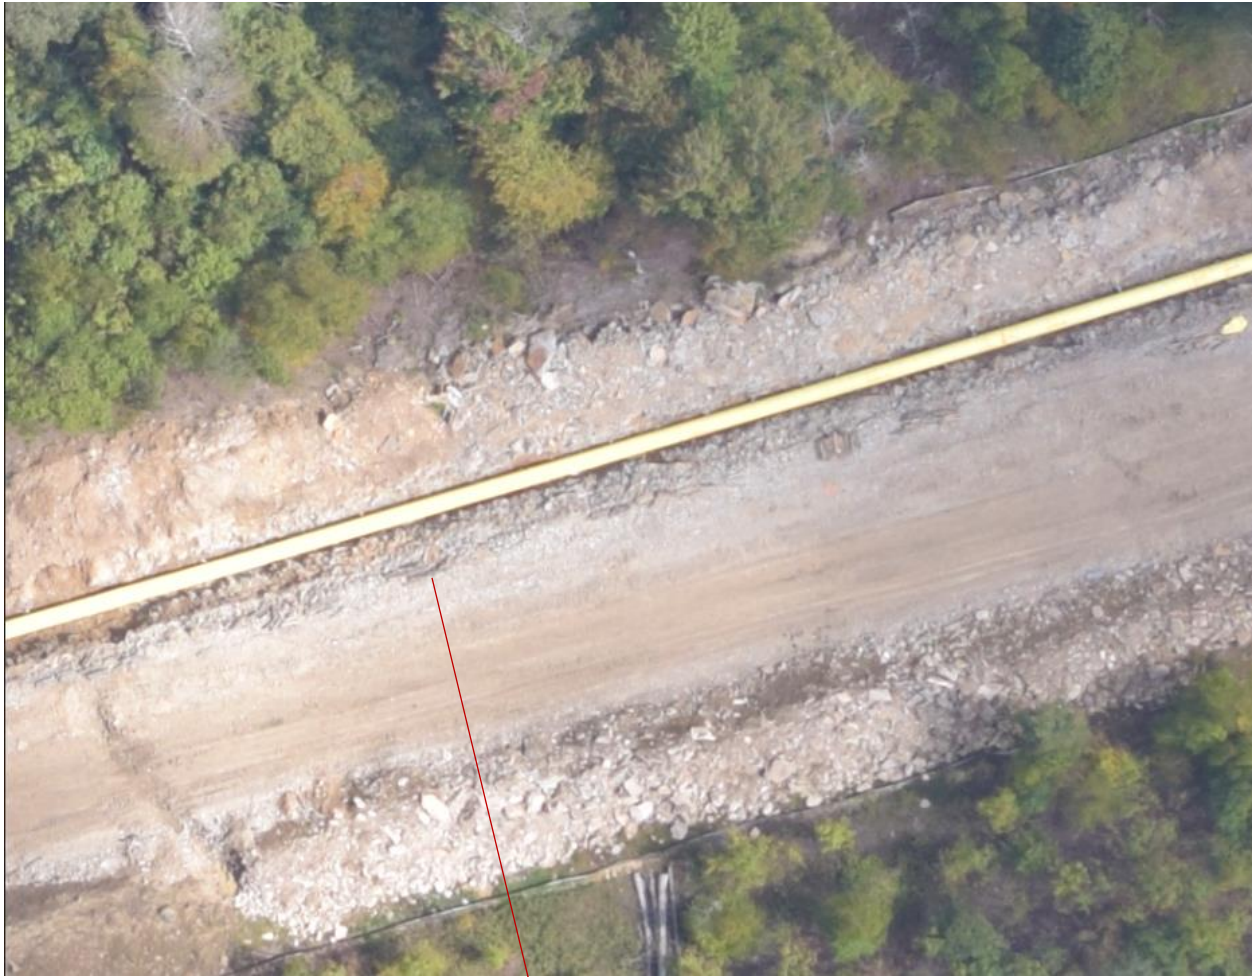
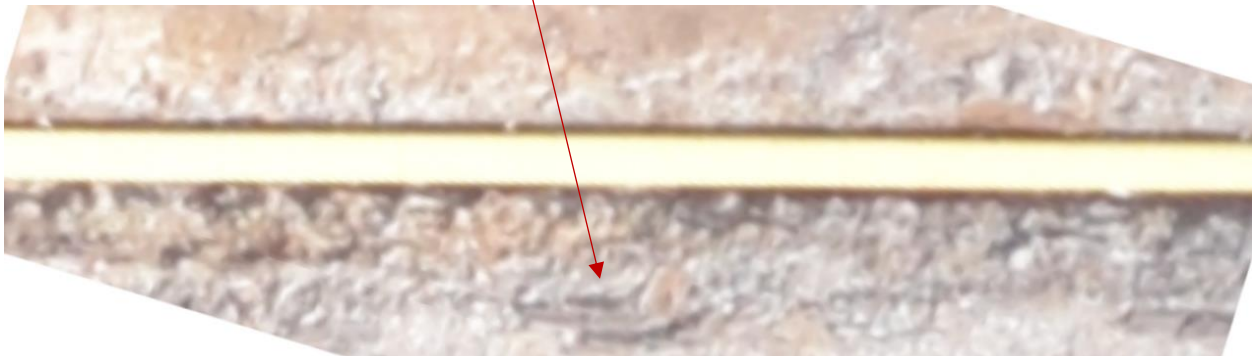
10/8/2018 875 MP 65.25 -80.136085, 38.554210

5,5 Strung pipe in "Rock-lined ditch".

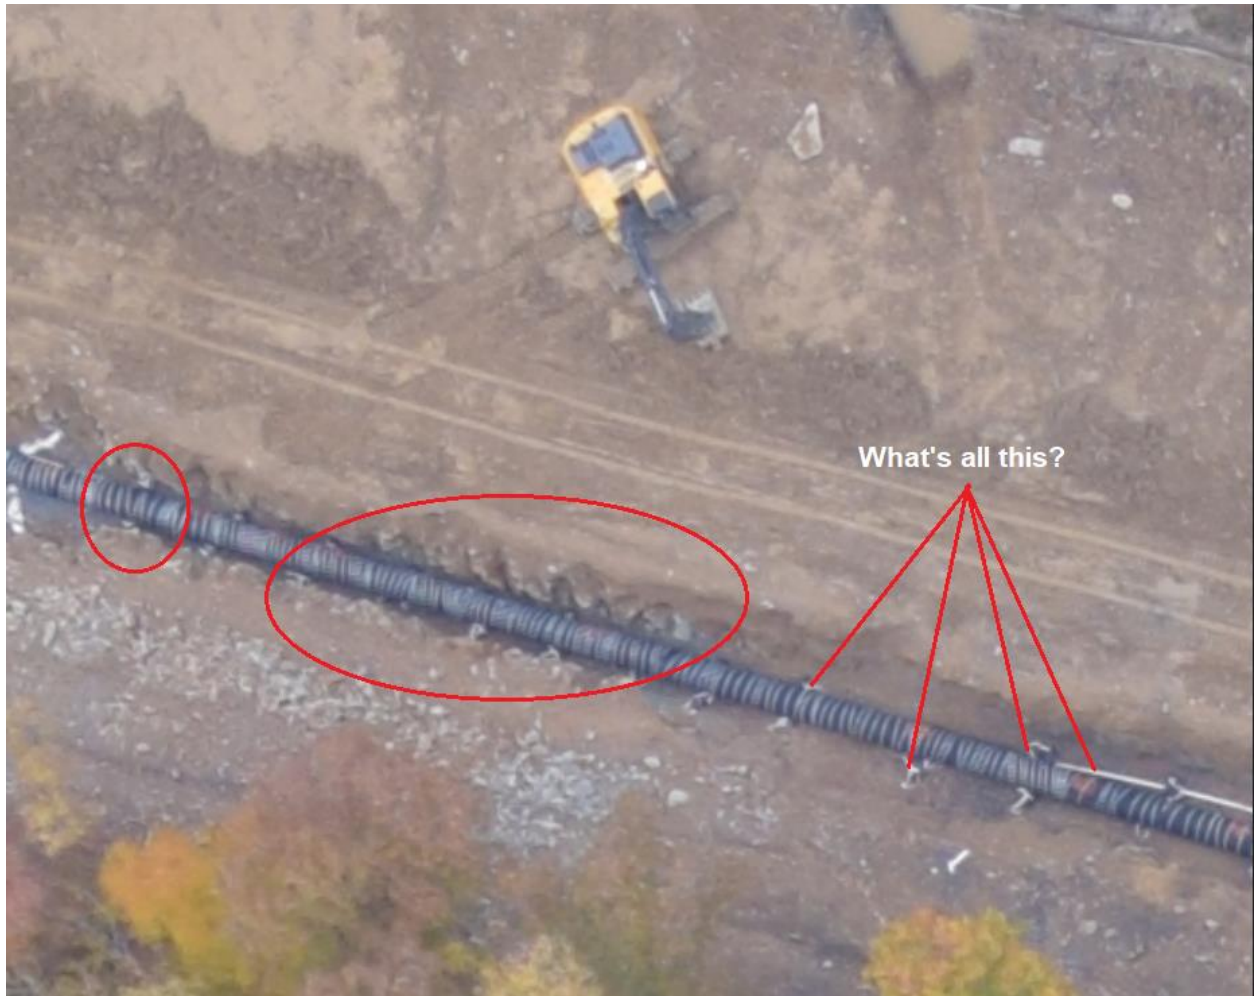
10/31/2018 1051 MP 35.75 -80.189626, 38.887708

4,3 Possible issue with bedrock jutting into very narrow trench. Debris in trench.

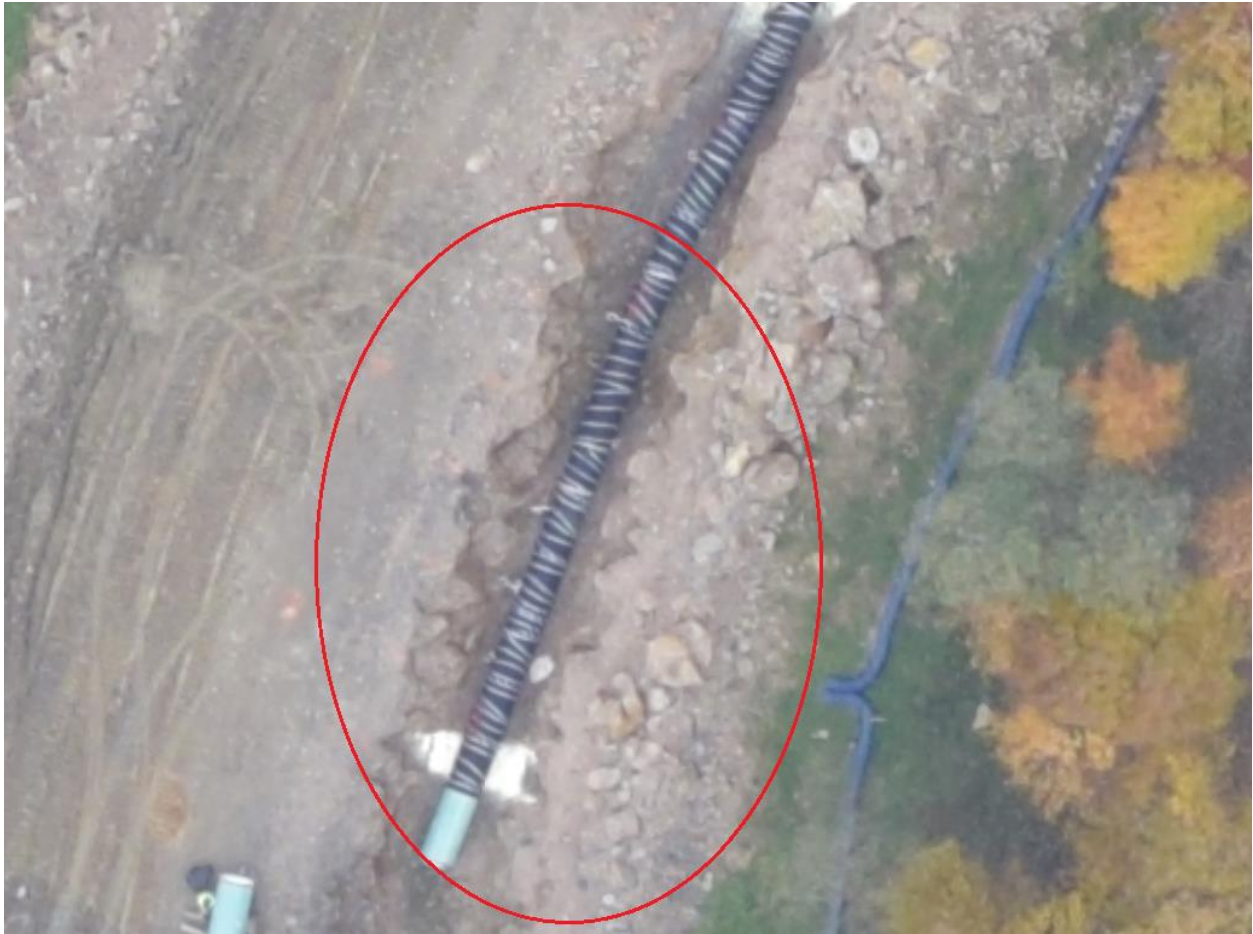
10/31/2018 1014 MP 37.82 -80.174899, 38.866629

5,4 Bedrock jutting into trench, bounders in trench
