Allegheny-Blue Ridge Alliance

RE: CPF 1-2019-1014W Warning Letter – Additional Info

Possible Construction Problem Areas – Atlantic Coast Pipeline

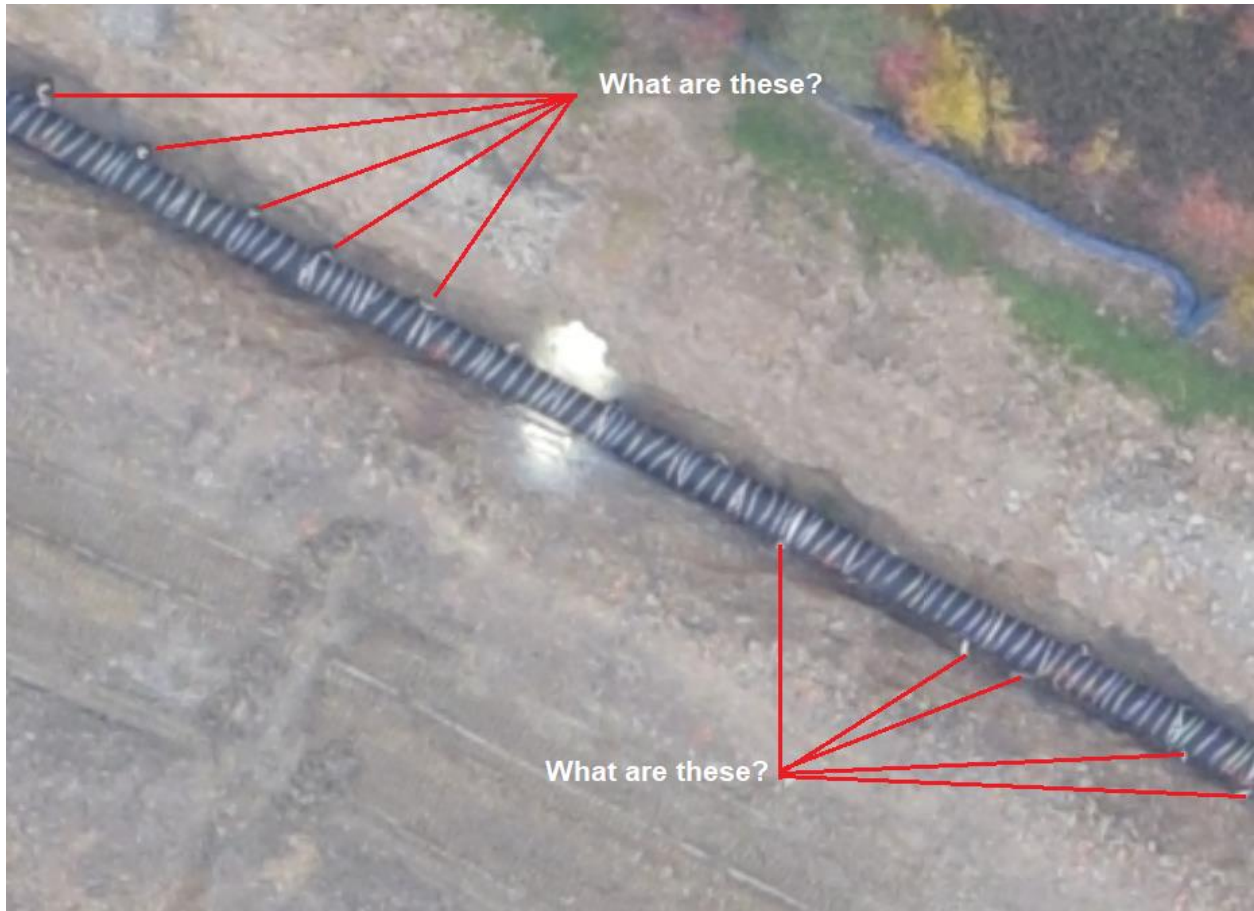
10/31/2018 1014 MP 37.82 -80.174899, 38.866629

5,6 Possible not-to-spec supports or "spacers" between pipe and trench wall.

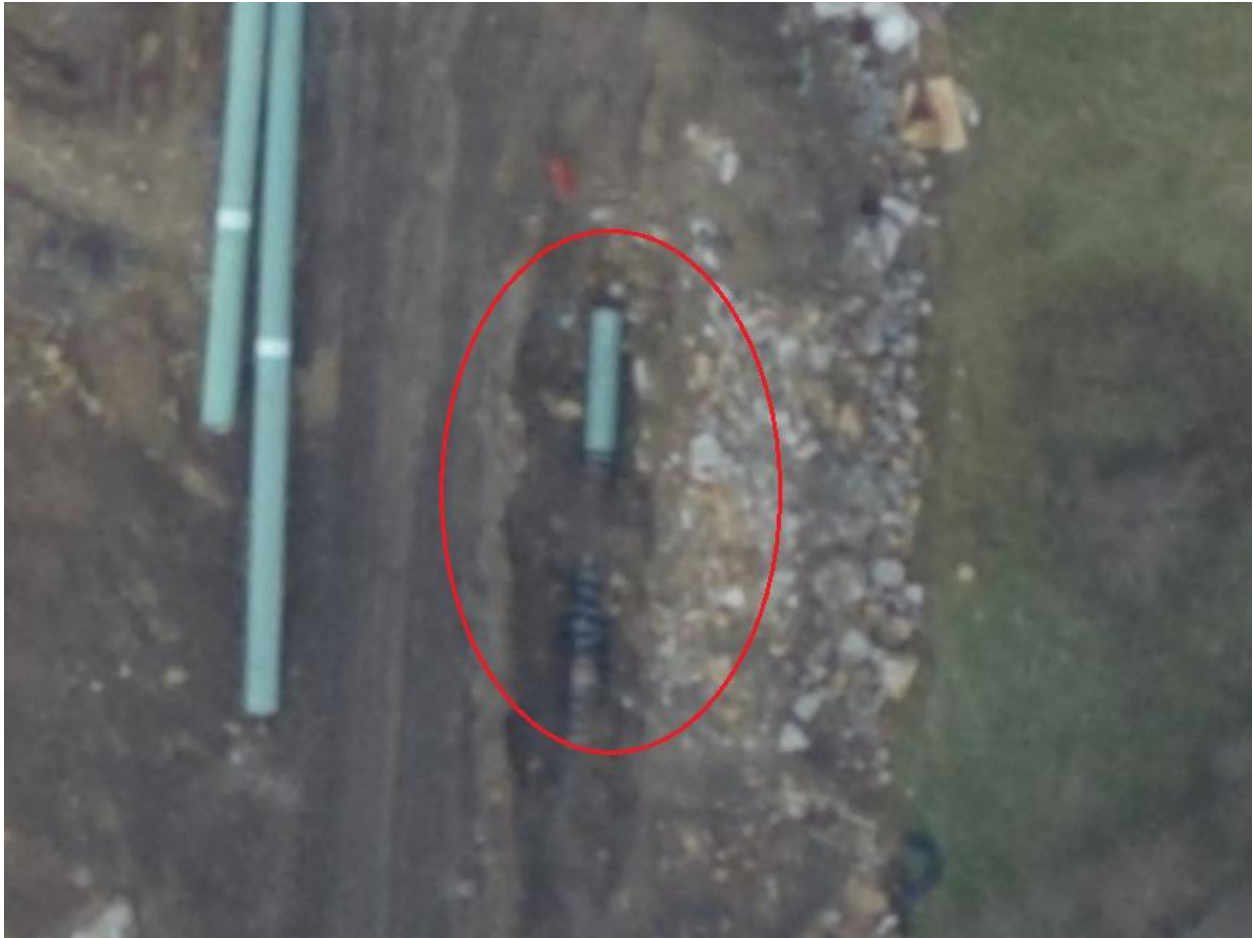
11/18/2018 956 MP 38.65 -80.164731, 38.859734

5,5 Rocks in trench with pipe as it daylight; 5,8 Bedrock jutting into trench on right w/in 1ft of pipe.

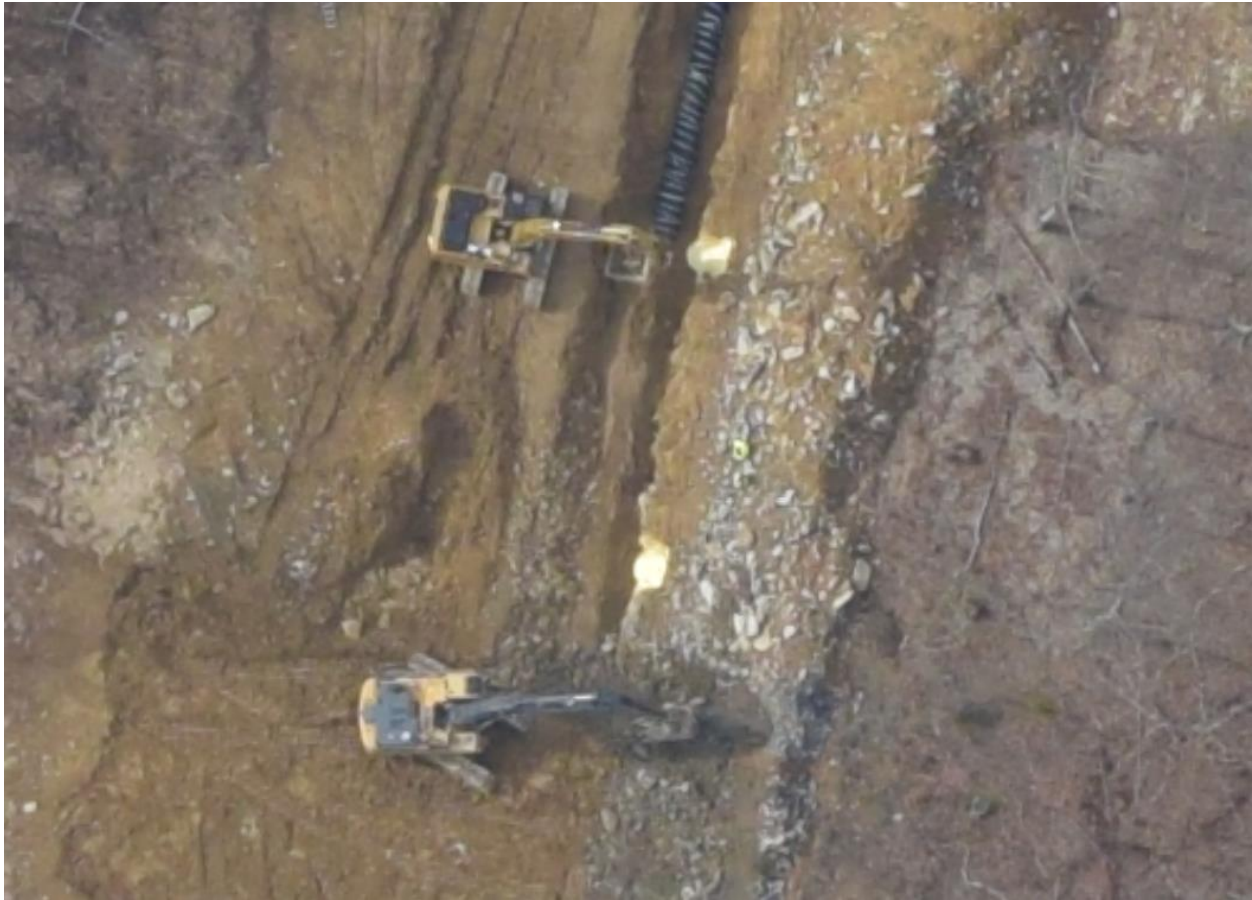
11/18/2018 944 MP 39.37 -80.158027, 38.853101

5,7 Active filling of rocky soil into trench on top of pipe. Does appear to be sifted fill underneath. More of the big foam (?) spacers.

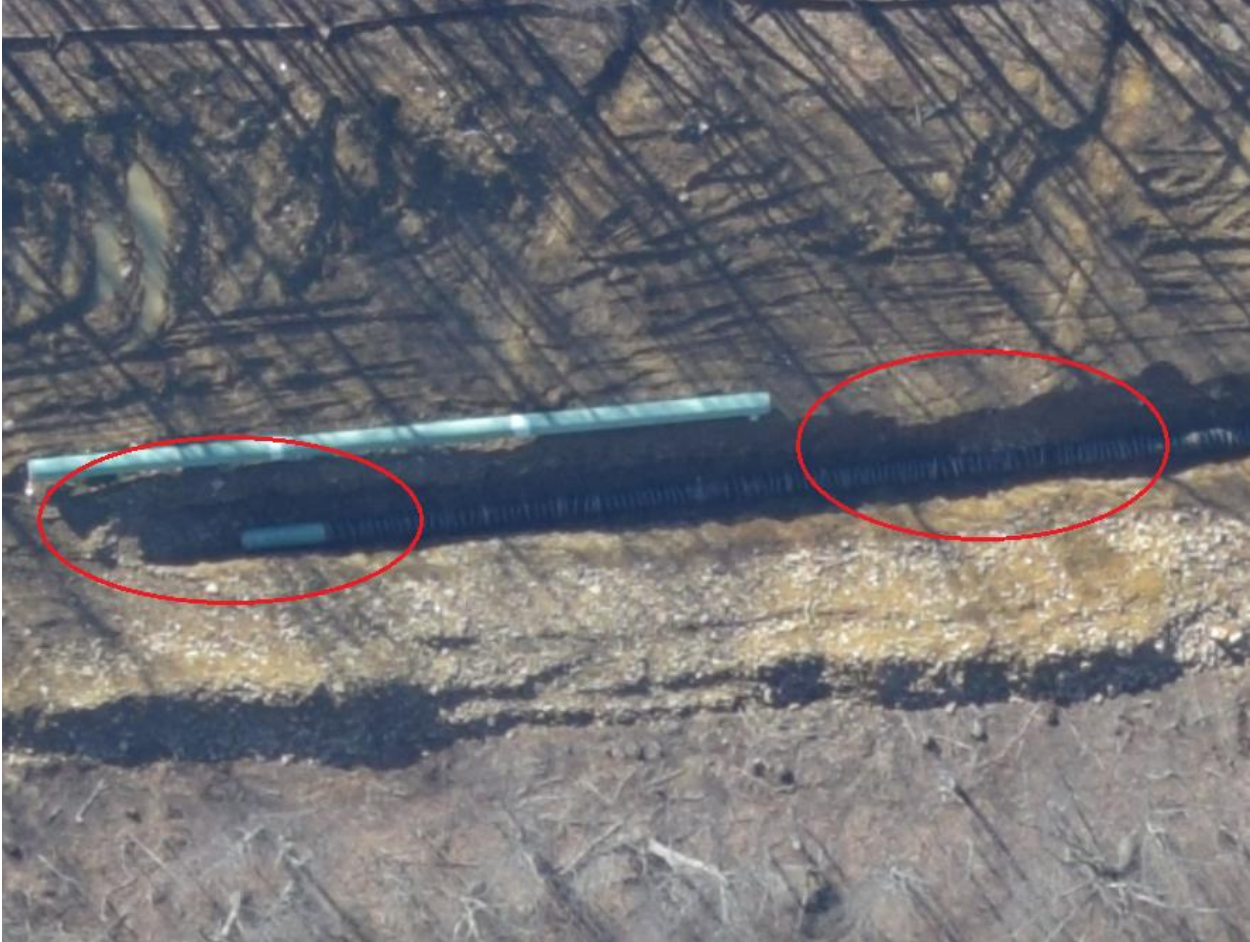
12/18/2018 952 MP 39.6 -80.154102, 38.851847

4,3; 4,5 Rocks and debris at open pipe end in trench; Rock/debris under against pipe in trench. Poor lighting...best available.

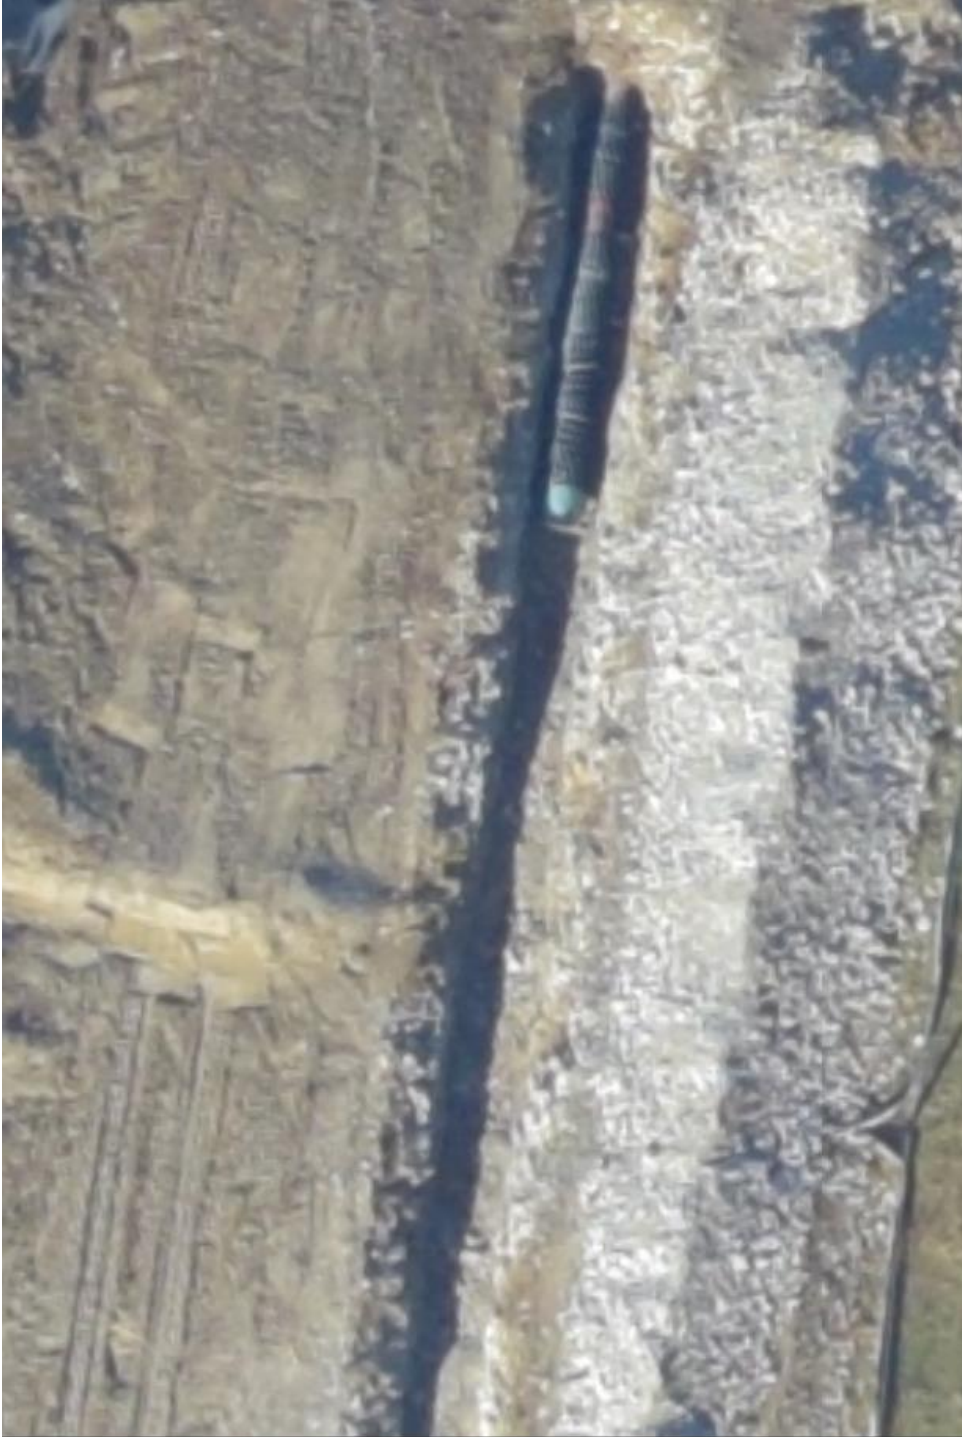
12/18/2018 938 MP 40.6 -80.139586, 38.844175

3,4 Pipe daylights into "rock-lined ditch".

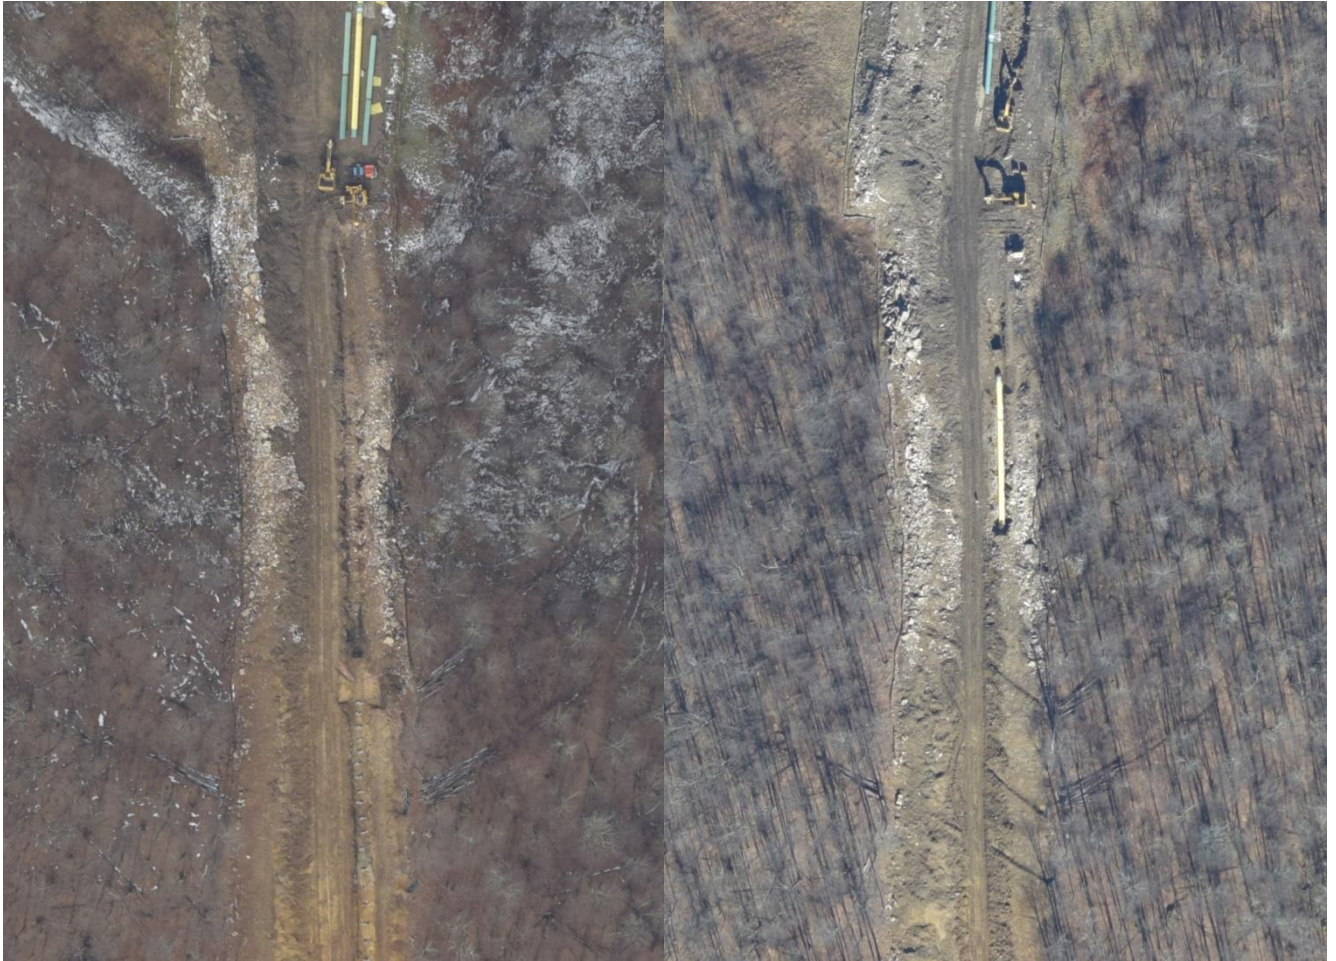
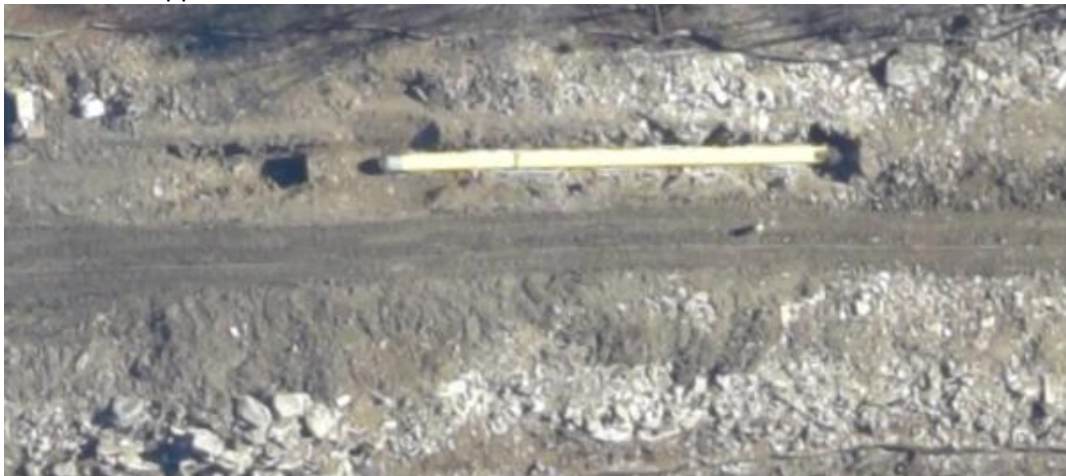
MP 65.66 -80.136532, 38.548243

Trench excavated in rocky soil. Pipe placed in trench with large rocks protruding from trench wall. Rocks in trench. Fill appears to contain rocks.
