Alliance calls proposed pipeline construction flawed

October 24, 2019

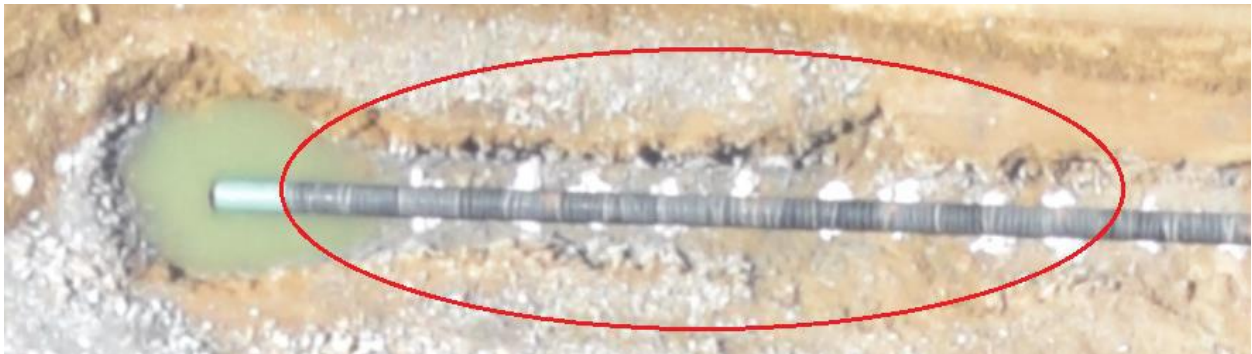
CSI identified 25 locations with large rocks loose in the trench, directly underneath the pipe. (Photo courtesy Allegheny Blue Ridge Alliance)

Shaffer explained, "CSI has identified 25 locations along the route that seem to show large rocks loose in the trench, directly underneath the pipe, incorporated with backfill, or protruding into the trench in close proximity to the pipe ... We are concerned that these conditions place the Atlantic Coast Pipeline at a significant risk of damage during hydrostatic testing, increased rates of corrosion due to damaged epoxy coating, or rupture due to landslides or even small slips."

Concluding, Shaffer said, "Our photographic evidence suggests that such conditions are common practice on this project. We feel that these locations warrant additional investigation to ensure that the project is being constructed in a safe manner."
