# Biological Assessment WV ERFO FS 2016, Storm Damage Repairs Pocahontas and Webster Counties, West Virginia

**Project Name:** Repair of Storm Damaged Roads, Monongahela National Forest  
(FHWA Project Numbers WV ERFO FS 2016-1(2), (3), (4), and (5))

**Date:** June 7, 2019

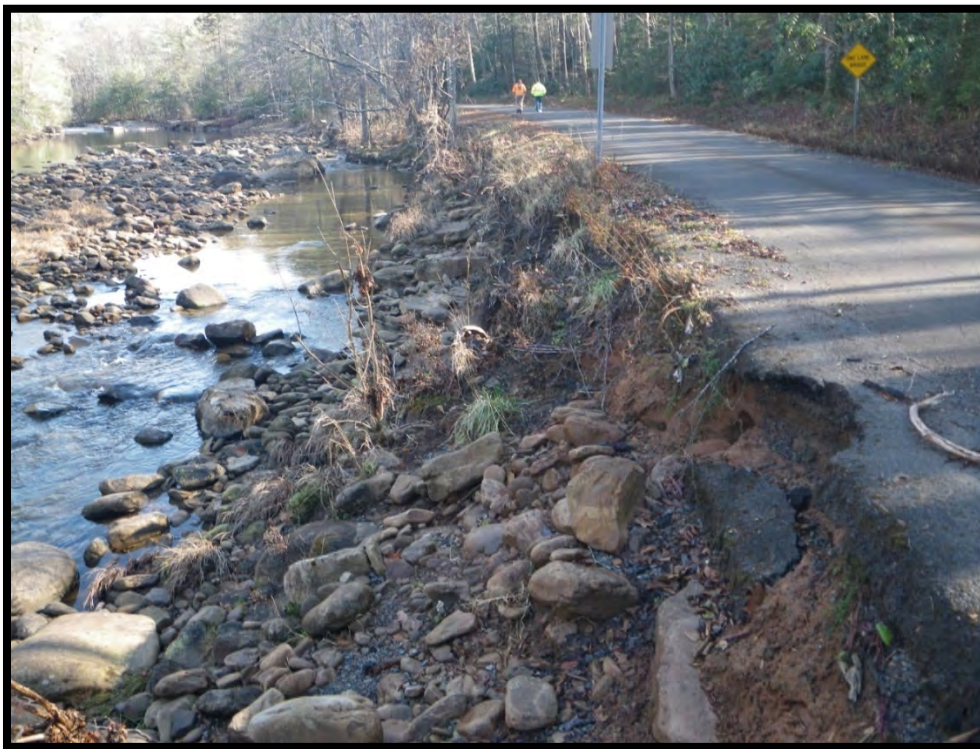
Figure 1. Williams River Road near MP 10.7, photo taken 11/30/2017

Williams River Road is a two-way road that primarily runs parallel to Williams River within the Monongahela National Forest. Williams River Road, designated as FS Road 86 within the project area, provides access to multiple rustic campsites. The damage locations for which repairs are proposed are located between and milepost 0.2 and milepost 18.4.

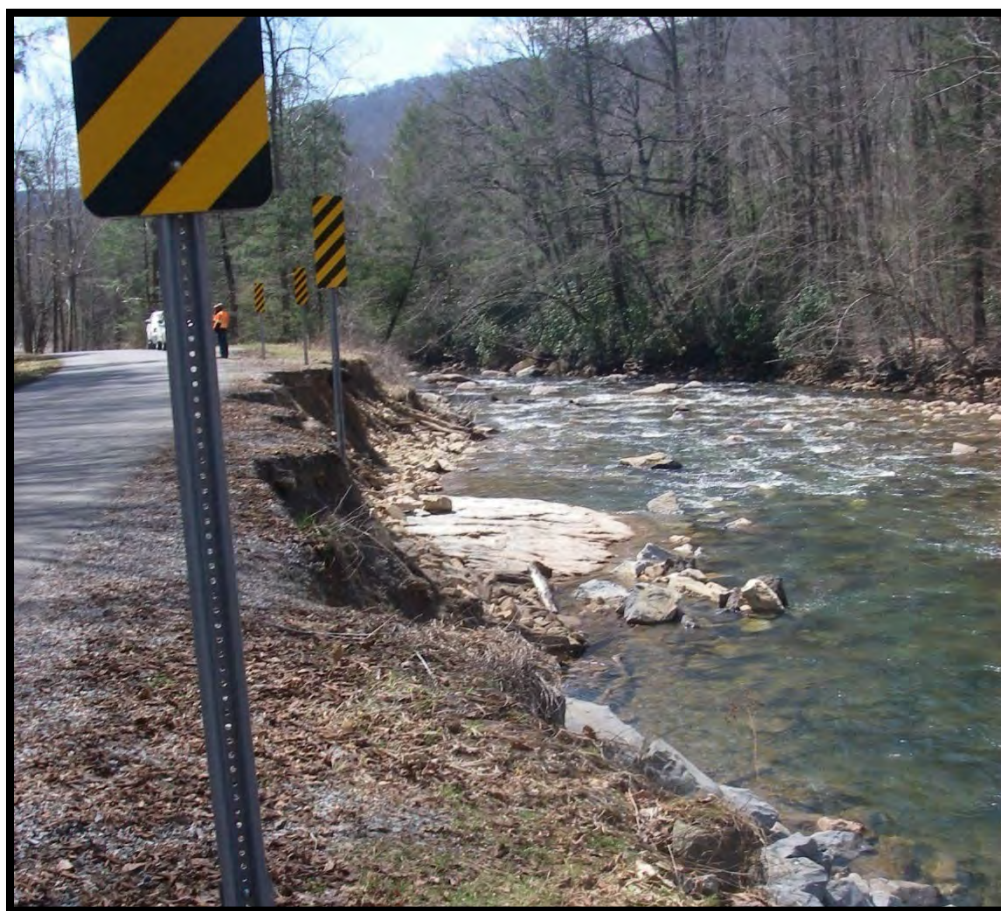
Figure 6. View of Williams River Road alongside the Williams River

The environmental baseline for this BA describes the current conditions in the action area. The action area consists of forested mountain slopes, forested coves, and riparian habitat. The Williams River and several streams are located in the action area. The Williams River begins on Black Mountain in Pocahontas County and flows west 33 miles to its confluence with the Gauley River near Cowen in Webster County. The Williams River has an average width of 40 feet in the action area.

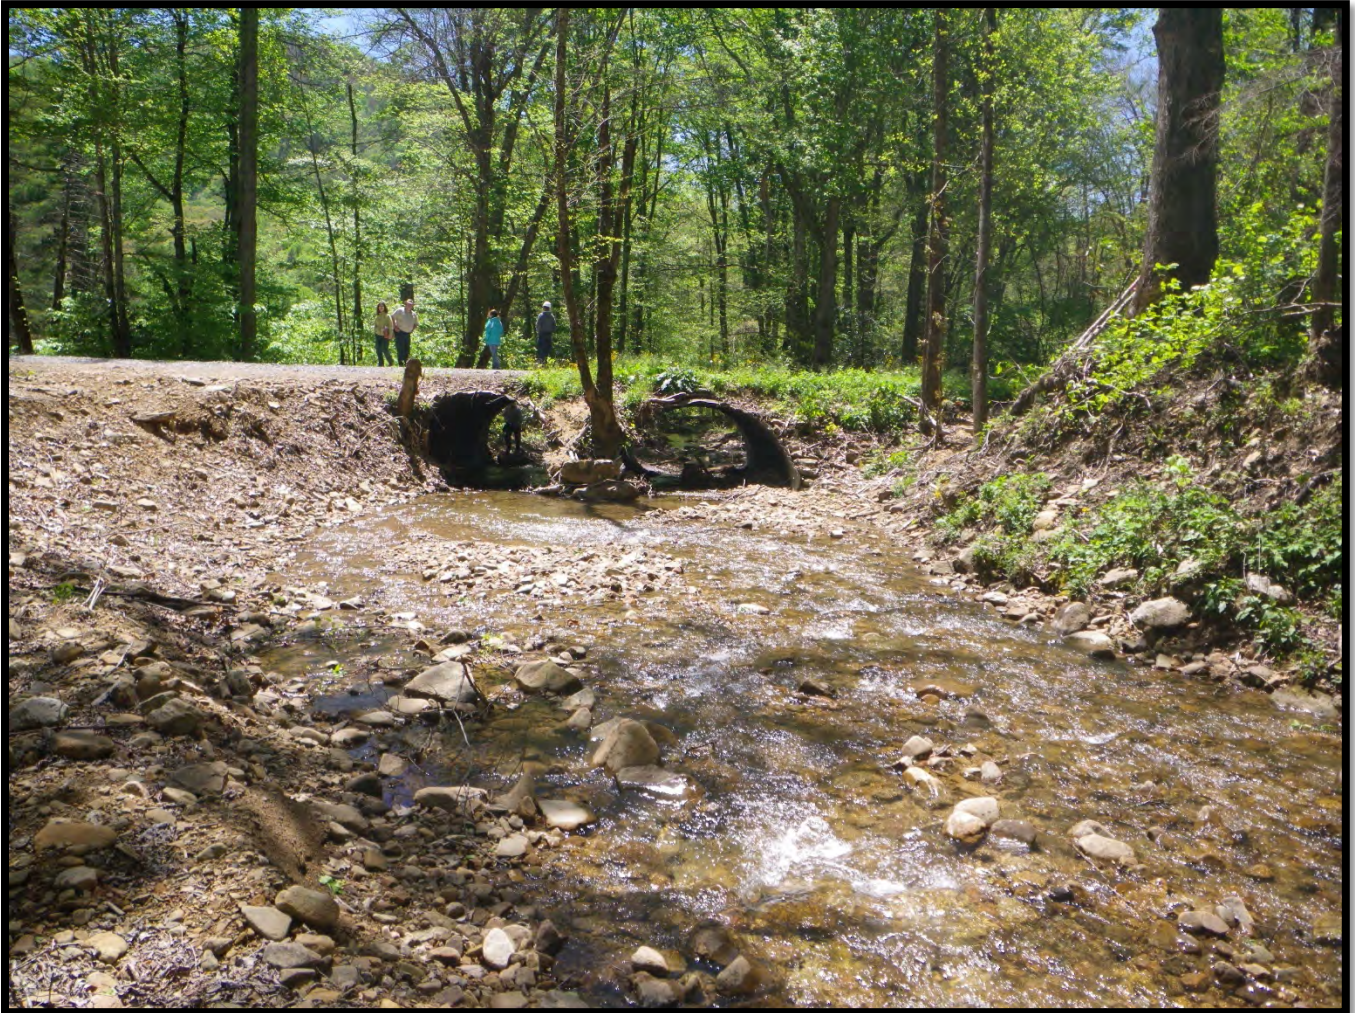
Figure 8. Culverts at Milepost 16.6, Photo Taken 5/3/2017

3. FS 86 at milepost 16.6: Shoulder and ditch reconditioning, and 72" double arch pipe replacement with bridge.

The existing double barrel arch pipes conveying White Oak Fork would be replaced with a 40-foot long single span concrete bridge. Any vegetation present, including 12 trees, would be cleared and erosion and sediment control measures would be installed. A temporary stream crossing would be constructed using a 50-foot long temporary bridge that would span the waterway to the south side of the existing bridge in order to maintain traffic during construction. A stream diversion, using sandbags, would be installed to divert stream flow through one pipe culvert working from the upstream end to the downstream end. The area behind the sandbags would be dewatered using pumps and filter bags and one of the arch pipes would be removed. Filter bags would be set in an adjacent upland area. The new bridge abutment would be constructed and rock would be installed to protect the abutment. The stream diversion would then be reconfigured to divert water through the other half of the channel so that the same work can be completed on the second side. The stream diversion would be removed and the rest of the bridge and roadway approaches would be constructed.

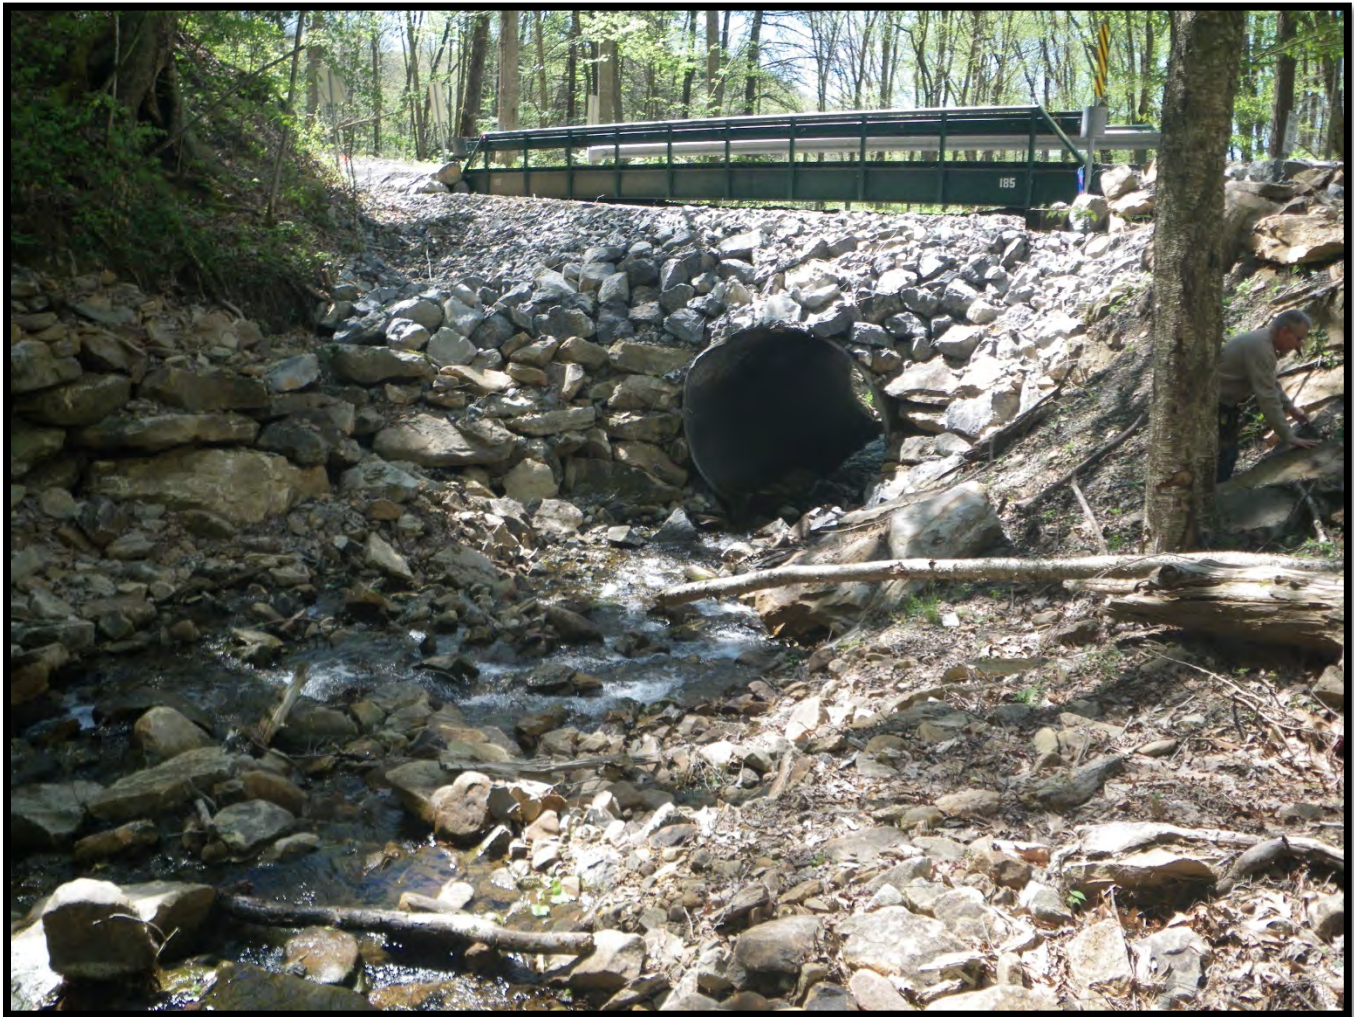
Figure 9. Culvert on FS 133 at Milepost 1.19, Photo Taken 5/3/2017

6. FS 133 at milepost 1.19: Culvert replacement with open bottom arch at MP 1.19 on FS 133

The existing 9-foot diameter culvert conveying a tributary to the Williams River would be replaced with a 30-foot span structural plate arch culvert, set on concrete footings. The longer span is not expected to change the flow of the stream, as it is intended to span the stream banks. Any vegetation present in the work area would be cleared and erosion and sediment control measures would be installed. The existing culvert would remain in place and the road and fill material around the culvert would be removed. Additional material would be excavated on each side of the culvert and the concrete footings would be constructed. Once the concrete footings are in place, the existing culvert would be removed. A stream diversion would be installed around one side of the channel to allow for the structural plate and riprap to be installed. The stream diversion would then be reconfigured and the stream would flow through the other side for the same activities to be completed on the remaining side. The area around and above the new culvert would be backfilled and the road would be reconstructed. Permanent seeding would be applied to revegetate all disturbed areas.

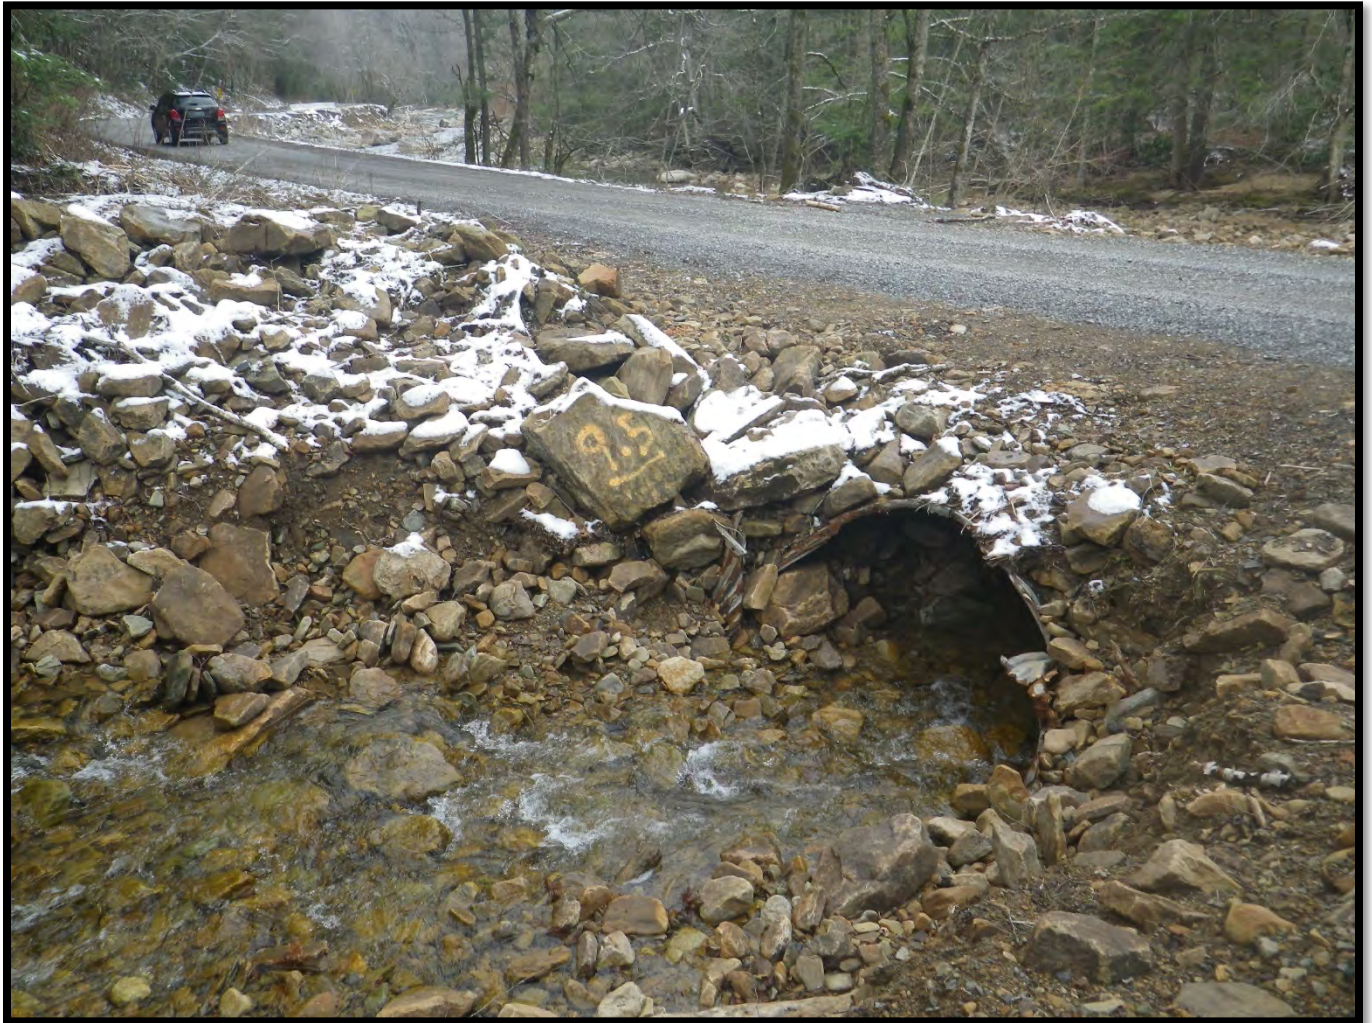
Figure 10. Culvert at Milepost 9.5, Photo Taken 4/10/2018

5. FS 86 at milepost 9.5: Replacement of existing 72" arch culvert with a box culvert, ditch and shoulder reconditioning and embankment reconstruction

The existing 72-inch arch culvert conveying Little Lick Branch to the Williams River would be replaced with a 12-foot span by 5-foot rise precast concrete box culvert. The work area would be cleared of vegetation and erosion and sediment control measures would be installed. Existing boulders would be removed as needed in order to install the temporary diversion channels and construct the bridge. A temporary diversion channel would be installed by excavating a new channel adjacent to the existing channel and lining the new channel with plastic or riprap. Sandbags would be placed at both ends of the diversion channel to prevent flow and backflow into the natural channel. Water will flow naturally through the diversion channel. The existing channel would be dewatered by pumping water out through a filter bag placed in an upland area.

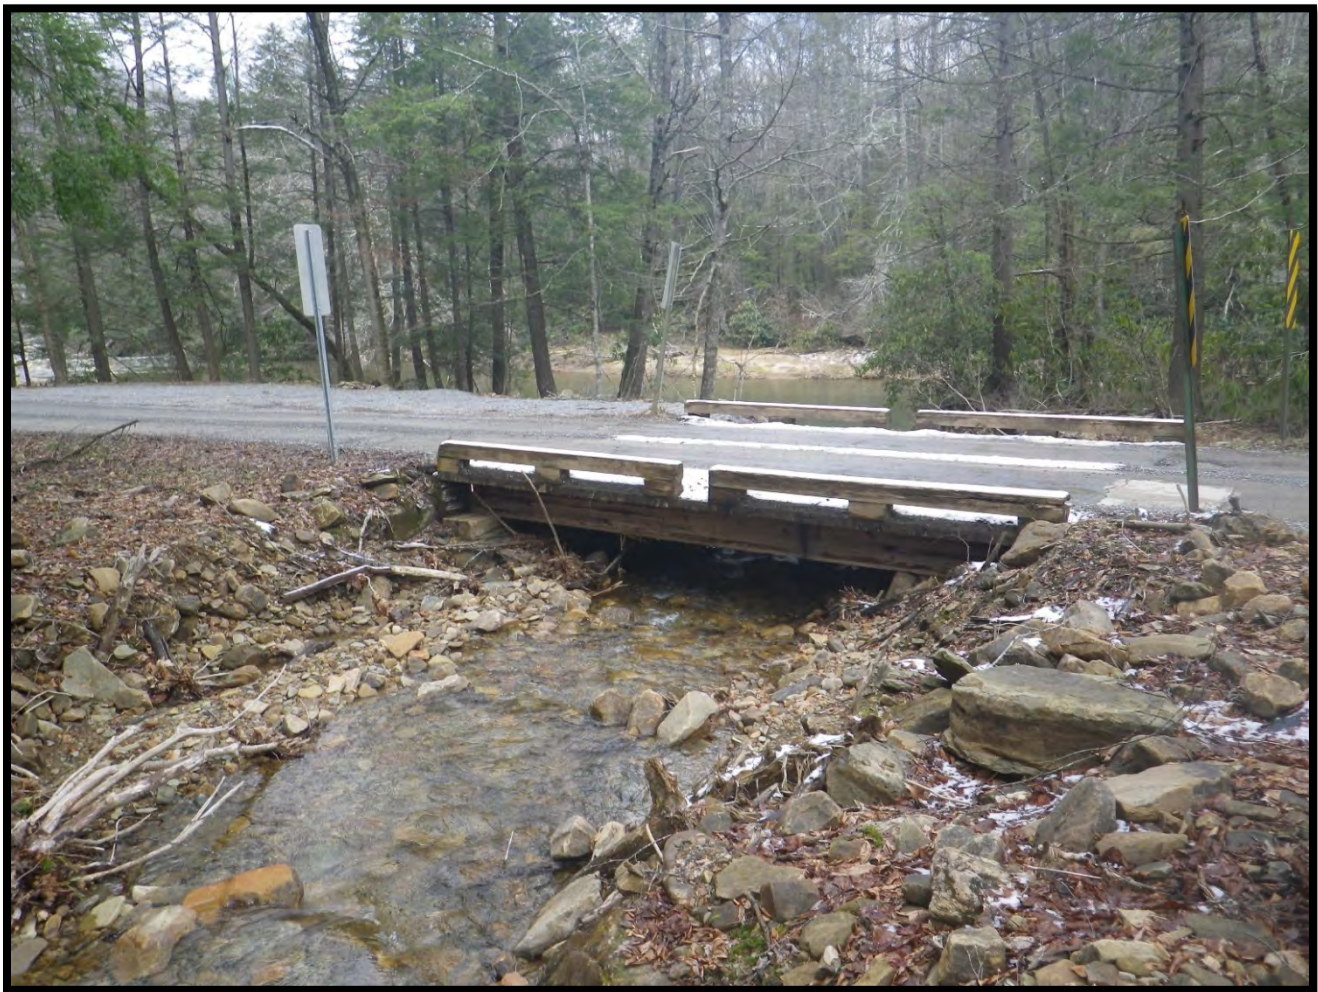
Figure 11. Timber Bridge at Milepost 10.8, Photo Taken 4/10/2018

10. FS 86 at milepost 10.7-10.8: Bridge replacement, embankment reconstruction, and ditch and shoulder reconditioning

The existing 20-foot long timber bridge with stacked stone abutments across Elbow Branch would be replaced with a 30-foot long single span concrete bridge. The work area would be cleared of vegetation and erosion and sediment control measures would be installed. Water would be diverted to flow down one side of the existing stream using sandbags. Existing boulders would be removed as needed in order to install the stream diversions and construct the bridge. One of the abutments and riprap would be constructed behind this diversion berm. After the completion of the first abutment, the flow would then be switched to the other side of the stream by reconfiguring the stream diversion to allow construction of the abutment and riprap on the other side. The bridge deck would be placed and the temporary stream diversion sandbags would be removed and the channel would be restored to natural conditions. The road approaches to the bridge would be reconstructed at a higher elevation to match the elevation of the new bridge.

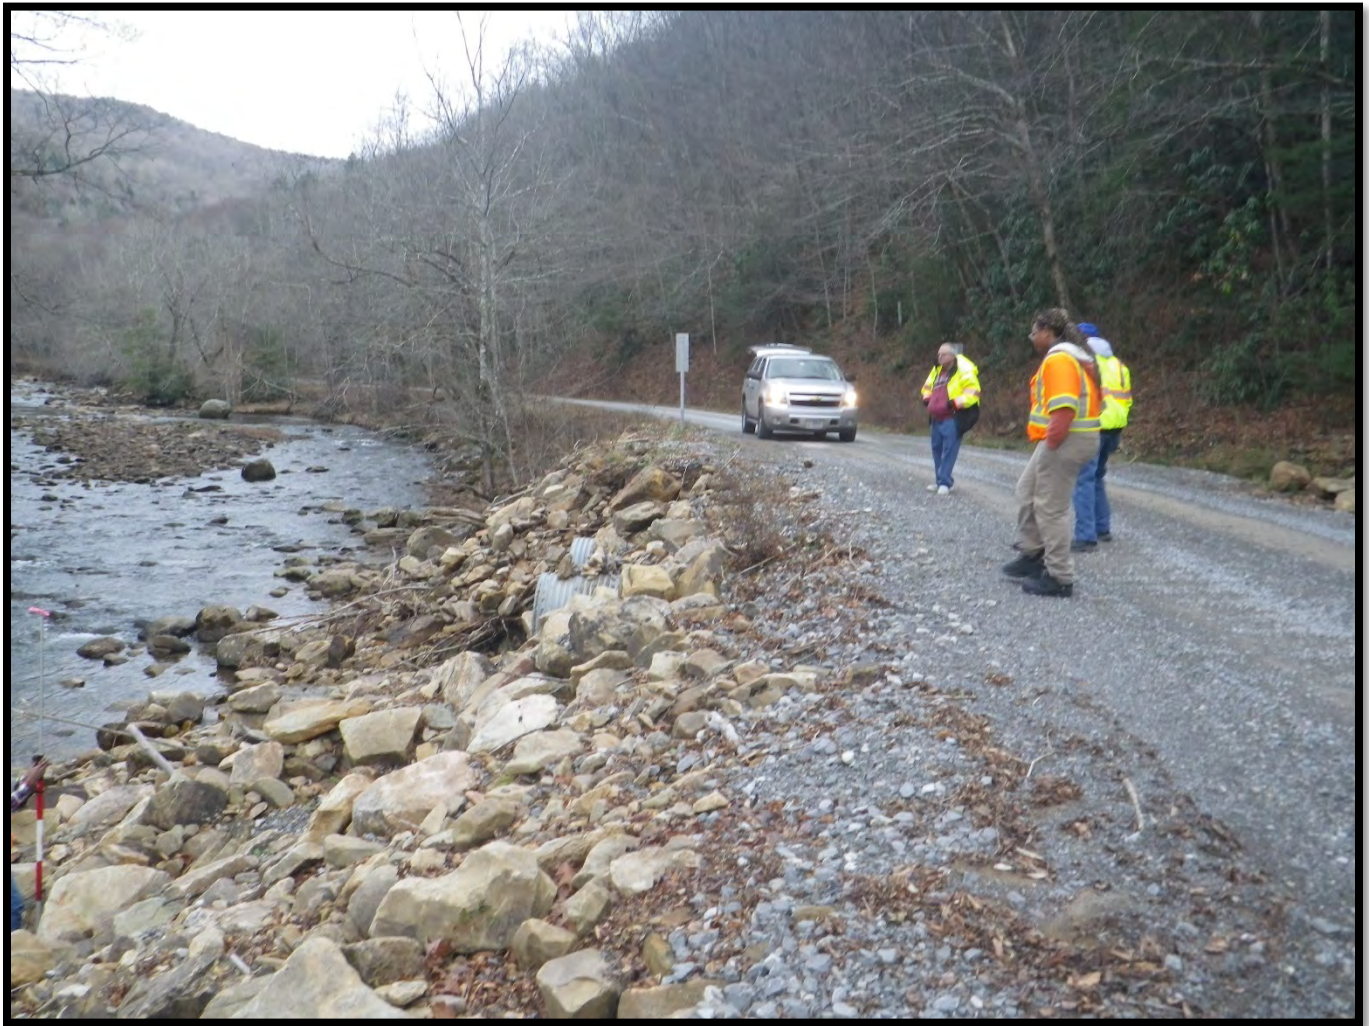
Figure 12. Culverts at Milepost 5.9, Photo Taken 11/30/2017

4. FS 86 at milepost 5.9: Replacement of existing double 54" culverts with box culvert, ACP.

The existing double 54-inch arch culverts conveying Hateful Run to the Williams River would be replaced with a 12-foot span by 6-foot rise concrete box culvert. The work area would be cleared of vegetation and erosion and sediment control measures would be installed. A temporary diversion channel would be installed by excavating a new channel adjacent to the existing channel and lining the new channel with plastic or riprap. Sandbags would be placed at both ends of the diversion channel to prevent flow and backflow into the natural channel. Water will flow naturally through the diversion channel, and will not require pumping. Existing boulders would be removed as needed in order to install the temporary diversion channels and construct the large culverts.

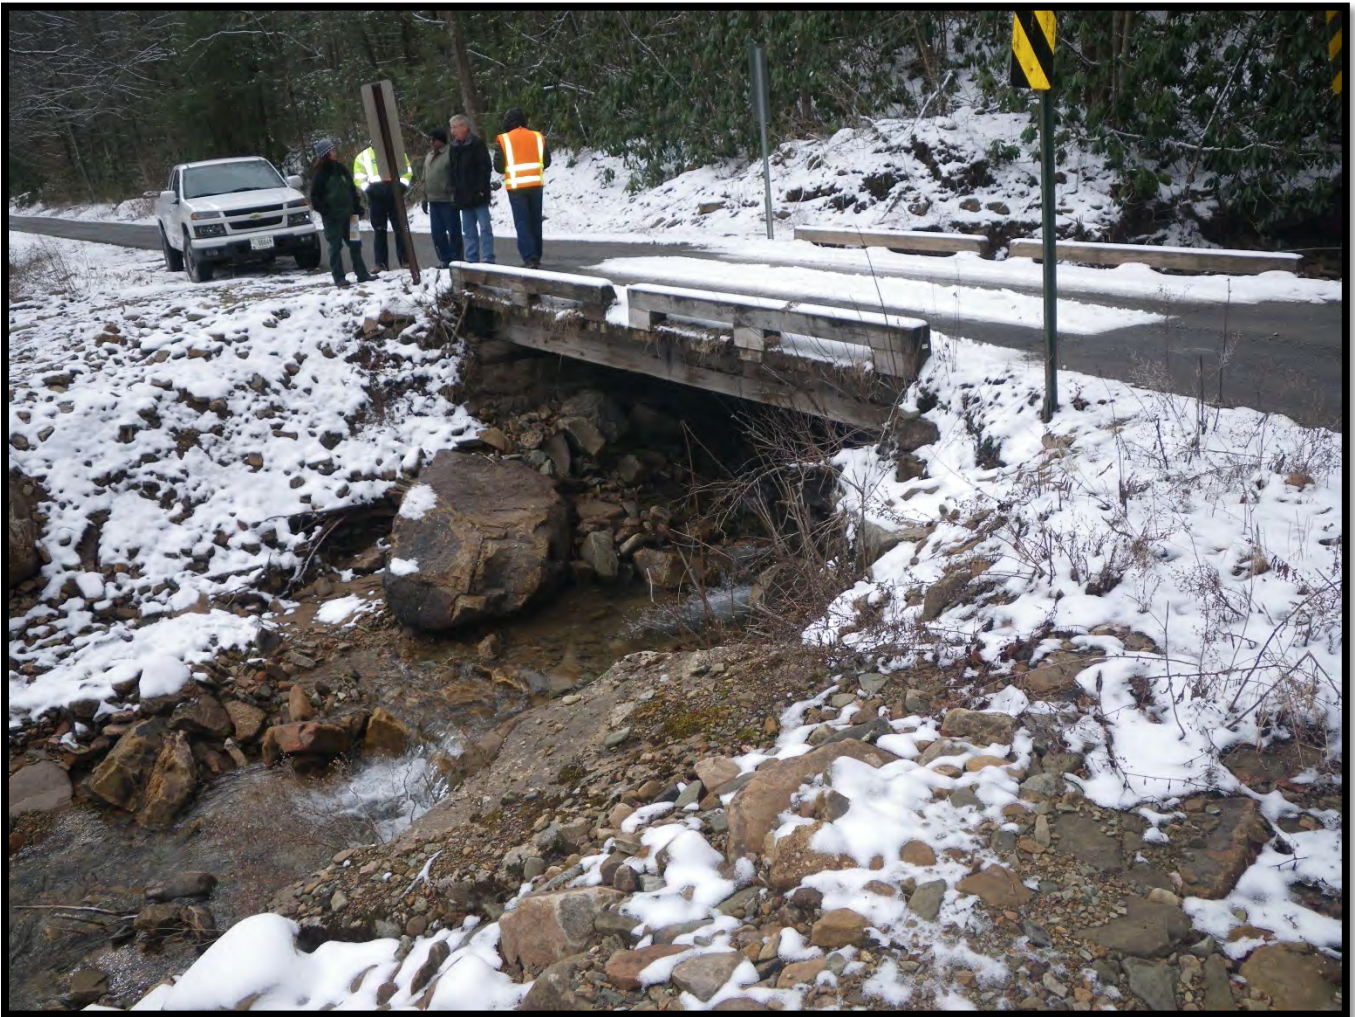
Figure 13. Timber Bridge at Milepost 6.7, Photo Taken 4/11/2018

8. FS 86 at milepost 6.7: Bridge replacement, and ACP.

The existing 20-foot long timber bridge with stacked stone abutments across Bridge Creek would be replaced with a 30-foot long single span concrete bridge. The work area would be cleared of vegetation and erosion and sediment control measures would be installed. Water would be diverted to flow down one side of the existing stream using sandbags. Existing boulders would be removed as needed in order to construct the bridge. The abutment and riprap would be constructed behind this diversion berm. The flow would then be switched to the other side of the stream to allow construction of the abutment and riprap on the other side. The bridge deck would be placed and the temporary stream diversion sandbags would be removed and the channel would be restored to natural conditions. The road approaches to the bridge would be reconstructed at a higher elevation to line up with the elevation of the new bridge.
