# ***LANDSLIDES***

# ***ACP***

An in-depth examination of the threat landslides  
pose to the Atlantic Coast Pipeline

June 2020

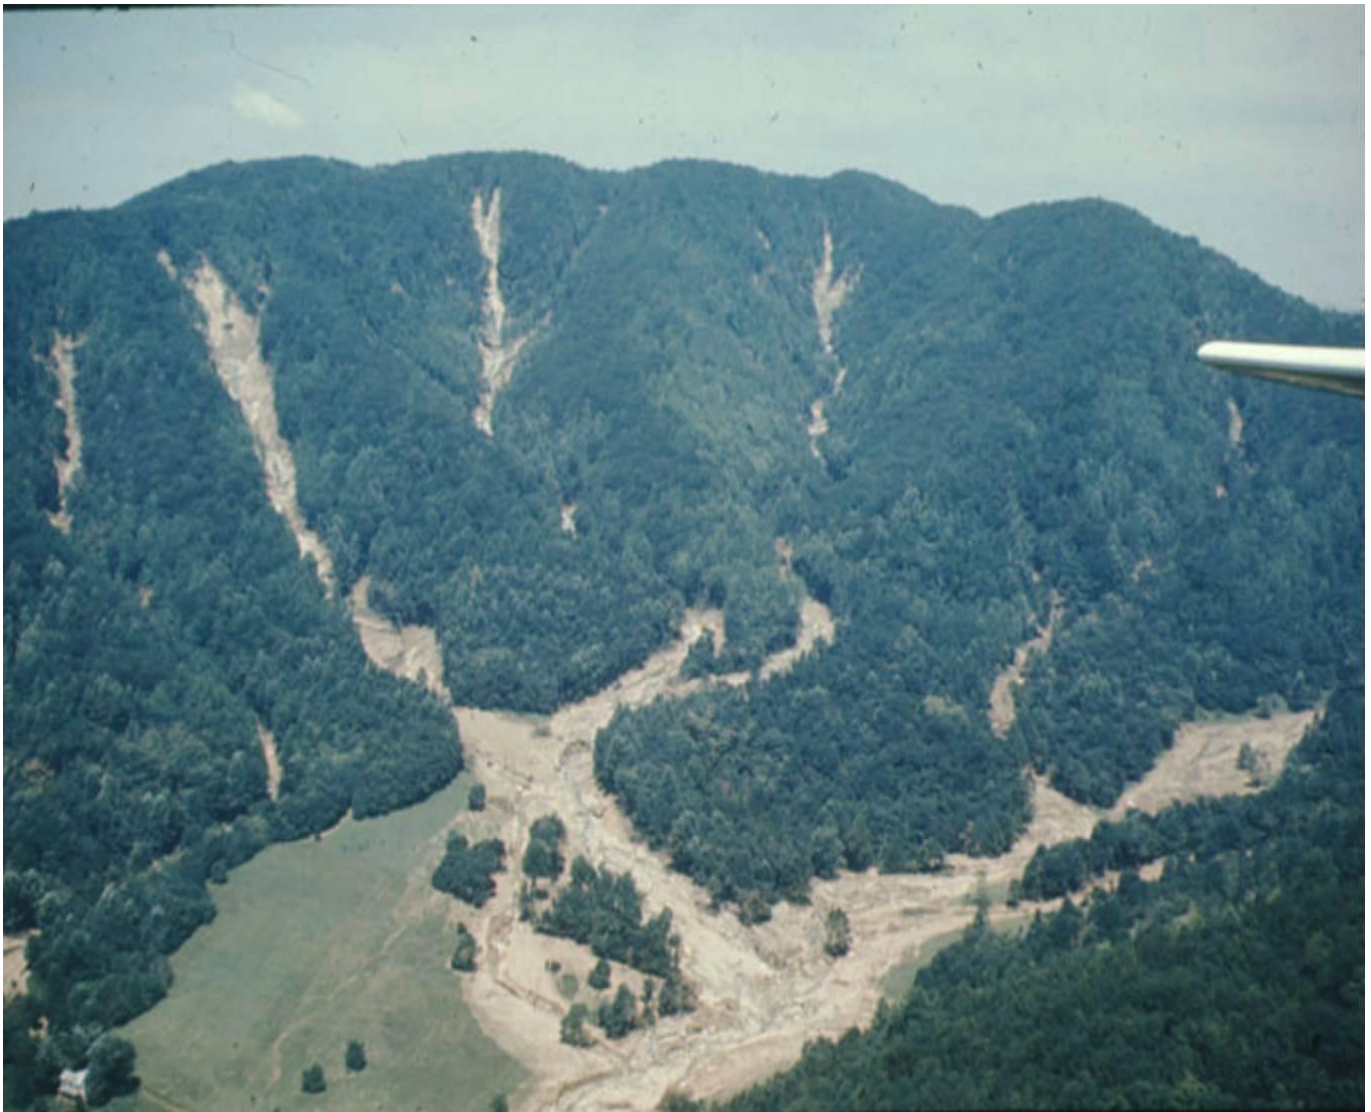
*Debris flow chutes after Hurricane Camille, in Nelson County<sup>42</sup>*

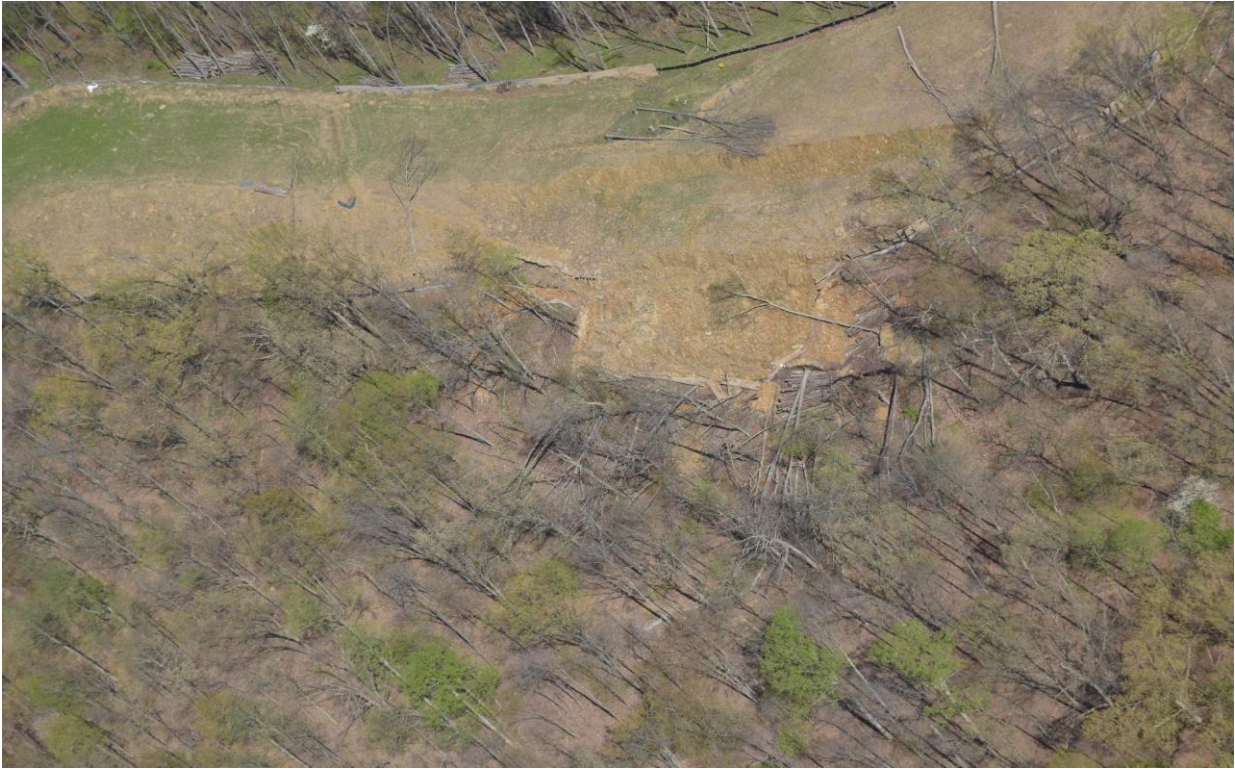
*Figure 1: landslide on ACP at milepost 1.7, view from above. Photo credit: ABRA Pipeline Airforce*

To date, less than 25 miles of the ACP has been completed through the mountainous portion of the route, and all of this has taken place on only moderately steep slopes in central West Virginia. However, Dominion has already self-reported over a dozen slope failures that either resulted from construction activity or were left out of the geohazard surveys (see Figures 1 and 2 below).

These problems have occurred along less-hazardous sections of the route that lack the sustained steep slopes of the terrain to the east.<sup>47</sup> Should ACP construction proceed into the steeper terrain in eastern West Virginia and western Virginia, the likelihood of additional slope failures will increase.

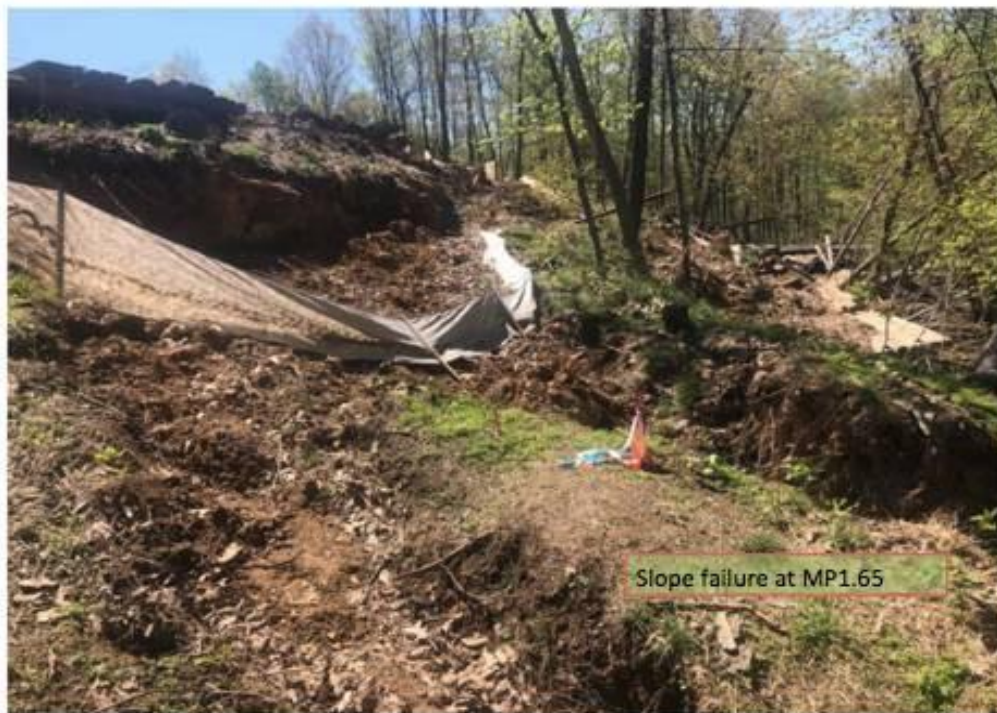
*Figure 2: landslide on ACP at milepost 1.7, view from below. Photo Credit: FERC*
